TECHNICAL REPORT: WATER Stewardship for stone fruit farmers Prepared for: World Wide Fund for Nature – South Africa

Prepared by: S. Dzikiti1, K. Schachtschneider ^{1,2} ¹Natural Resources and Environment, Council for Scientific & Industrial Research (CSIR) ²Freshwater Program, WWF-SA Emails: sdzikiti@csir.co.za kschacht@wwf.org.za

January 2015

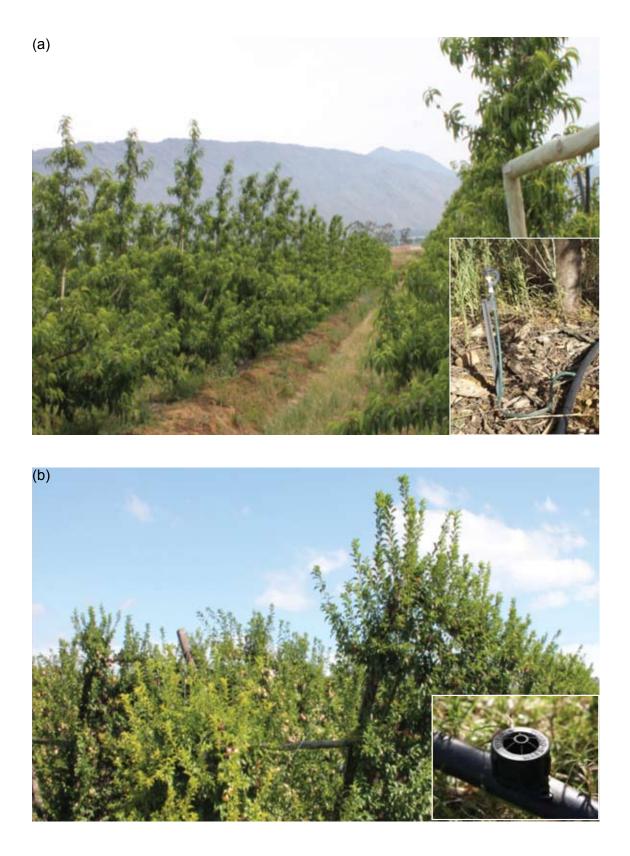
Fig 1. (a) Four year old Juli Pretty orchard at Denou farm in Ceres with Microjet sprinklers. (b) Five year old African Delight plum orchard on V-Haag trellis at Sonskyn farm in Robertson with pressure compensated drip emitters, spaced every 75 cm along the irrigation line delivering water at a rate of 2.0 L/h.

Measurements in the peach orchard were done in a four year old Juli Pretty orchard at Denou farm in Ceres (Fig 1a). This cultivar has the longest growing season and therefore it's water use is close to the maximum for peach in the area. The trees are budded on the 778 rootstock and total size of the orchard is about 4 ha. Trees are planted on ridges with a spacing of 4 m between rows and 1.5 m within the rows. Irrigation is via medium range micro-sprinklers delivering about 32 L/h. The plum trial was conducted in a five year old African delight orchard budded on the GF-677 rootstock at Sonskyn farm in Robertson. Area of the orchard is about 3 ha. The trees are trained on a V-Haag trellis system with 10 wires with dual rows running in an east-west direction on a drip irrigation system (Fig 1b). Spacing was about 5 m between rows and 1.5 m within rows. This plum cultivar is also the longest season cultivar harvested during March-April.
