Audit Report

ALLIANCE FOR WATER STEWARDSHIP CERTIFICATION

TAIWAN SEMICONDUCTOR MANUFACTURING COMPANY LIMITED, 8, LI-HSIN RD. 6, HSINCHU SCIENCE PARK, HSINCHU 300-78, TAIWAN, R.O.C.

PREPARED BY: DNV GL BUSINESS ASSURANCE TAIWAN | DATED: 25 JANUARY 2021 | VERSION: 01

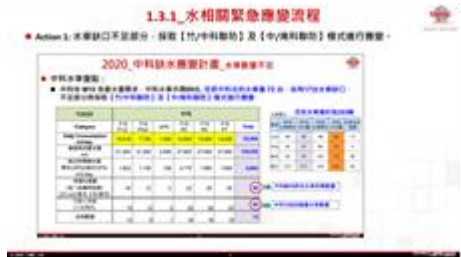
1.3.1	Existing water-related incident response plans shall be identified	Conformed	<p>1. Compare the F-CQC-01-03-001 effluent quality treatment process, A-RMS-08-03-283 water shortage response measures. Currently identify three types of risks and emergencies, including water pollution, water shortage, heavy rain and typhoon caused water pollution, so F-CQC-01-03-001 effluent treatment</p>	<p>Minor During the audit, it was found that in the current emergency response plan based on the identified water-related incident response plans, during the dry season, A-RMS-08-03-283 TSMC's raw water supply shortage crisis management internal control</p>	<p>Root cause: The contract of Y2019 water truck and water source meets the needs of the Taichung plant. Mass production of Y2020 F15P7 will begin this year. The purchasing department is currently active in looking for other water sources to contract.</p> <p>Corrective Action: Action 1: Adopt the "Hsinchu Science Park and Central Taiwan</p>

<p>process, mainly focus on F- , NH3, TMAH, Cu2+ and pH, A-RMS-08-03-283 water shortage response measures , A-RMS-08-02-037 notification time limit for environmental protection incidents, A-RMS-08-03-210 environmental protection incident notification process, F-JWT-04-03-001 rainwater shutoff valve self-inspection management were setup and implemented. The implementation situation meets the requirements of the procedure.</p> <p>2. The current water supply situation in central Taiwan is due to drought, indicating that the water status light is yellow. Fab 15A and Fab 15B have started saving water usage up to 5%. Compared with the average in August as the baseline, the water saving situation meets the requirements. If the water status light turns to orange, the factory affairs-new constructions convene the relevant departments to decide on the reduction measures, and implement autonomous water saving of 5%, 7.5% and 10% respectively. When the light became orange, water saving target will set as 10% or the red light, it will be set as 20%, and the</p>	<p>operation procedure 2020-09-15 V5 should be implemented to make contingency, however the current plan does not specify the timing required to finalize the different proportions of the contracted water rights under the different water shortage conditions at each stage. When the water shortage limit set by the process as 20%, which means the target will be 15% in terms of the amount of water rights that need to be contracted after deducting 5% of self-saving, the number of contracts currently confirmed is not enough.</p>	<p>Science Park joint defense" and "Central Taiwan Science Park and Southern Taiwan Science Park joint defense" modes to deal with the insufficiency of the water truck.</p> <p>Action 2: Continue to cooperate with Zhuo Han, the purchasing department, to increase the number of water trucks in the contract.</p>

<p>Correction action was reviewed and closed by DNV GL.</p>

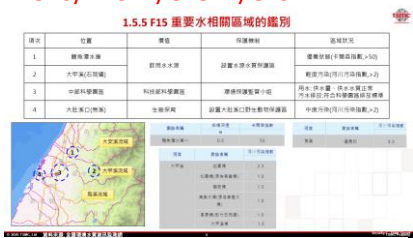
1.5.5	Important Water-Related Areas shall be identified, and where appropriate, mapped, and their status assessed including any threats	Conformed	During the audit, it was found that although the identification of important water-related areas is currently carried out, the identification results are inconsistent with the requirements for important	<p>Minor</p> <p>During the audit, it was found that although the identification of important water-related areas is currently carried out, the identification results are</p>	<p>Root cause:</p> <p>The process of identifying Important Water-related Areas did not consider the continuity of each chapter.</p> <p>Corrective Action:</p>

to people or the natural environment, using scientific information and through stakeholder engagement.		water-related areas in various criteria of the standard, including 1.3.6/1.8.4/3.5.1/3.9.4. Detailed please refer to the non-conformities. During the audit process, the identification of important water-related areas has been re-examined.	inconsistent with the requirements for important water-related areas in various criteria of the standard, including 1.3.6/1.8.4/3.5.1/3.9.4. During the audit process, the identification of important water-related areas has been re-examined, and the requirements of each criteria should be compared horizontally to ensure the consistency of the results.	<p>At the AWS meeting, the Important Water-related Areas were determined and the contents of each chapter were revised to reach consensus: Important Water-related Areas contain:</p> <p>1. Liyutan Reservoir 2. Deji Reservoir 3. Central Taiwan Science Park 4. Dadu River , and are consistent with chapters 1.3.6/1.8.4/3.5.1/3.9.4</p>

<p>Correction action was reviewed and closed by DNV GL.</p>

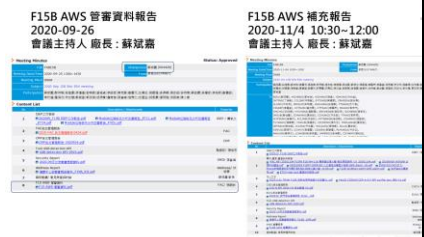
in Indicator 2.1.1 and is signed by the organization's senior-most executive or governance body and publicly disclosed shall be identified.		and published in TSMC's website; 2, Water Management section in TSMC's website; 3, The AWS Report signed by Corporate EHS Director and published in TSMC's website; 4, TSMC CSR Report 2019 published in its website; 5, "Sustainable Water Resources Management Goals and Plans-F15" issued in plant level.	During the audit, it was found that although "Sustainable Water Resources Management Goals and Plans-F15" have been sorted out as a statement document describing various goals and objectives covering water management issues, the document has a description of the contents of the implementation plan. During the inspection process, it was found that there may be an opportunity to update, which will be able to more fully present the current implementation direction drawing. also, the document has not been formally signed and issued by the top executive responsible person or department of the site, which may affect its validity as a basis for implementation.	<p>The revised items in the review process will be supplemented by the plant-level safety committee on November 4 (Moderator: plant director Su Binjia).</p> <p>2.1.2_F15 涵蓋各項水管裡指標的聲明</p>

<p>The action plan was deemed appropriated by DNV GL.</p>

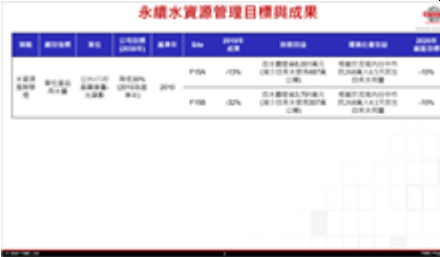
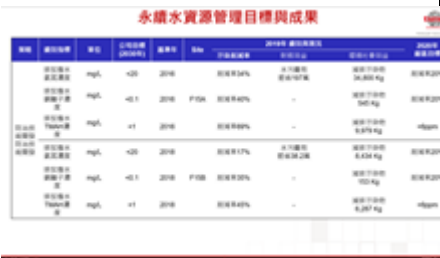
<p>risks and 1.7.2 opportunities, such as insufficient water supply, facility failure, and water supply quality. Detailed please refer to the non-conformities.</p>

<p>During the audit process, the content of AWS "Sustainable Water Stewardship Strategy Management Goal and Plan F-15" has been reviewed and consolidated based on the five main outcomes of AWS.</p>

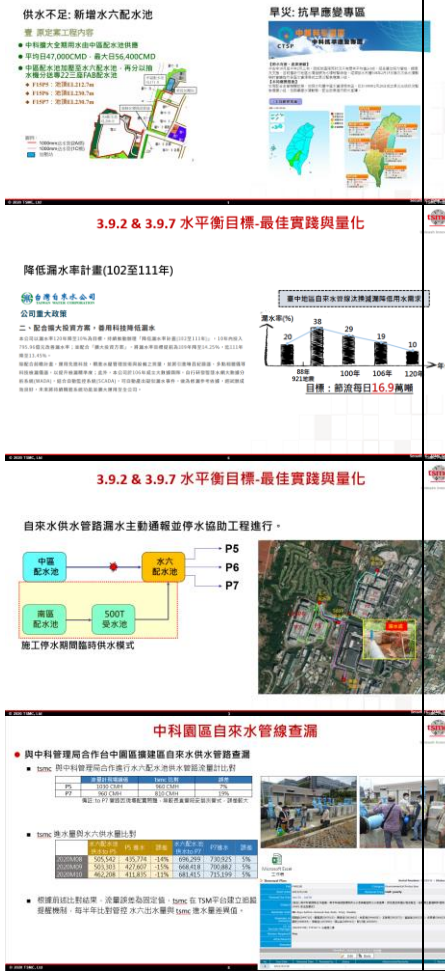
<p>water leakage rate in the water pipe network.</p> <p>3.9.2 & 3.9.7 水平衡目標-最佳實踐與量化</p>

3.9.7 ADV	Achievement of identified best practice related to targets in terms of sustainable water balance shall be quantified	0	<p>1, The AWS Report signed by Corporate EHS Director and published in TSMC's website;</p> <p>2, TSMC CSR Report 2019;</p> <p>3, as ditto in 3.9.6</p> <p>4, the CAPA raised due to the OBS can be follow up during succeeding assessment.</p>	<p>OBS</p> <p>While Interviewing with stakeholders, it was found that city water pipe leaking rate is one of water supply topic since 921 earthquakes. This topic could be defined as shared water challenge.</p>	<p>Root cause:</p> <p>Corrective Action:</p> <p>In light of the fact that the leakage rate of the water supply network belongs to the business of the Taiwan Water Corporation, we would cooperate with the Central Taiwan Science Park Bureau to conduct regular comparisons of the water volume and leakage detection of the tap water supply pipes in the expansion area of Central Taiwan Science Park. We have also established a TSM regular reminder system to facilitate the follow-up and continuous tracking and updating the information of</p>

<p>The action plan was deemed appropriated by DNV GL.</p>
3.9.8 ADV	Achievement of identified best practices related to targets in terms of water quality shall be quantified	8	1, The AWS Report signed by Corporate EHS Director and published in TSMC's website; 2, TSMC CSR Report 2019 ; 3, Technology development on WWT;	-	-

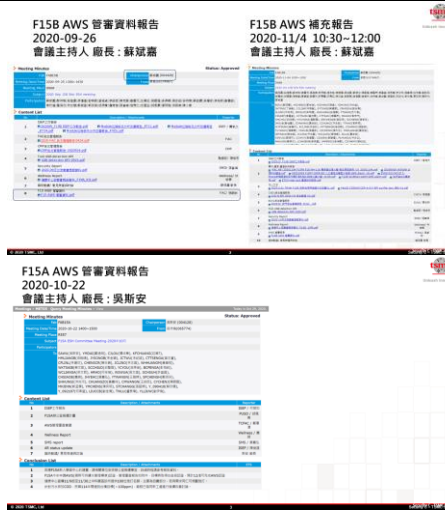
<p>3.7.3_F15 Indirect water_Green Supply Chain節能/節水</p>

<p>對供應商訂有用水量管理指標, 並每年評估乙次供應商績效, 如供應商未達成績效, 未來的管理做法持續追蹤</p> <p>The organization had defined suppliers' water KPI and evaluate their achievement annually. However, for the suppliers who didn't achieve the KPI, the corrective process is not clear.</p>		<p>The action plan was deemed appropriated by DNV GL.</p> <ul style="list-style-type: none"> ■ 設定高資源消耗供應商減量目標 <ul style="list-style-type: none"> ◆ 減量短期目標(2021 年): 節水累計達 400 萬噸 (基準年: 2018) ◆ 減量長期目標(2030 年): 節水累計達 2400 萬噸 (基準年: 2018) <p>每年 Q2 前收集相關廠商減量績效, 對無法達標的供應商將持續輔導。</p> <ul style="list-style-type: none"> ■ Set a goal to reduce high resource consumption vendors <ul style="list-style-type: none"> ◆ Short-term goal for reduction (2021): Cumulative water saving reach 4 million tons (base year: 2018) ◆ Long-term goal for reduction (2030): Cumulative water saving reach 2400 million tons (base year: 2018) <p>The reduction performance of relevant vendors will be collected before Q2 of each year, and the continuous guidance for vendors who are unable to reach the set standards.</p>
