Alliance for Water Stewardship Assessment Report Prepared for CAMPOS DEL SUR S. A.

Prepared by: SGS

CAMPOS DEL SUR S. A. Farms: DON CÉSAR; DON GONZALO; LITO; y TRONQUITOS

Agricultural Crops of Table Grapes

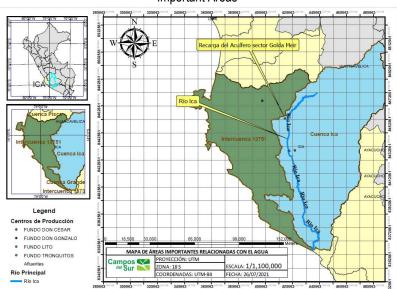
Figure N ° 4.1 Important Areas

The site does not Evidence that within its geographic scope it has important areas related to water; however, it identified the following areas due to their importance with the ICA River Basin:

- TAMBO River.
- CHOCLOCOCHA Lagoon.
- GOLDA MEIR.
