Alliance for Water Stewardship Assessment Report

Prepared for SA des Eaux Minérales de Ribeaupillé (Carola) (AWS-000422)

Prepared by: SGS

Date: March 7, 2022

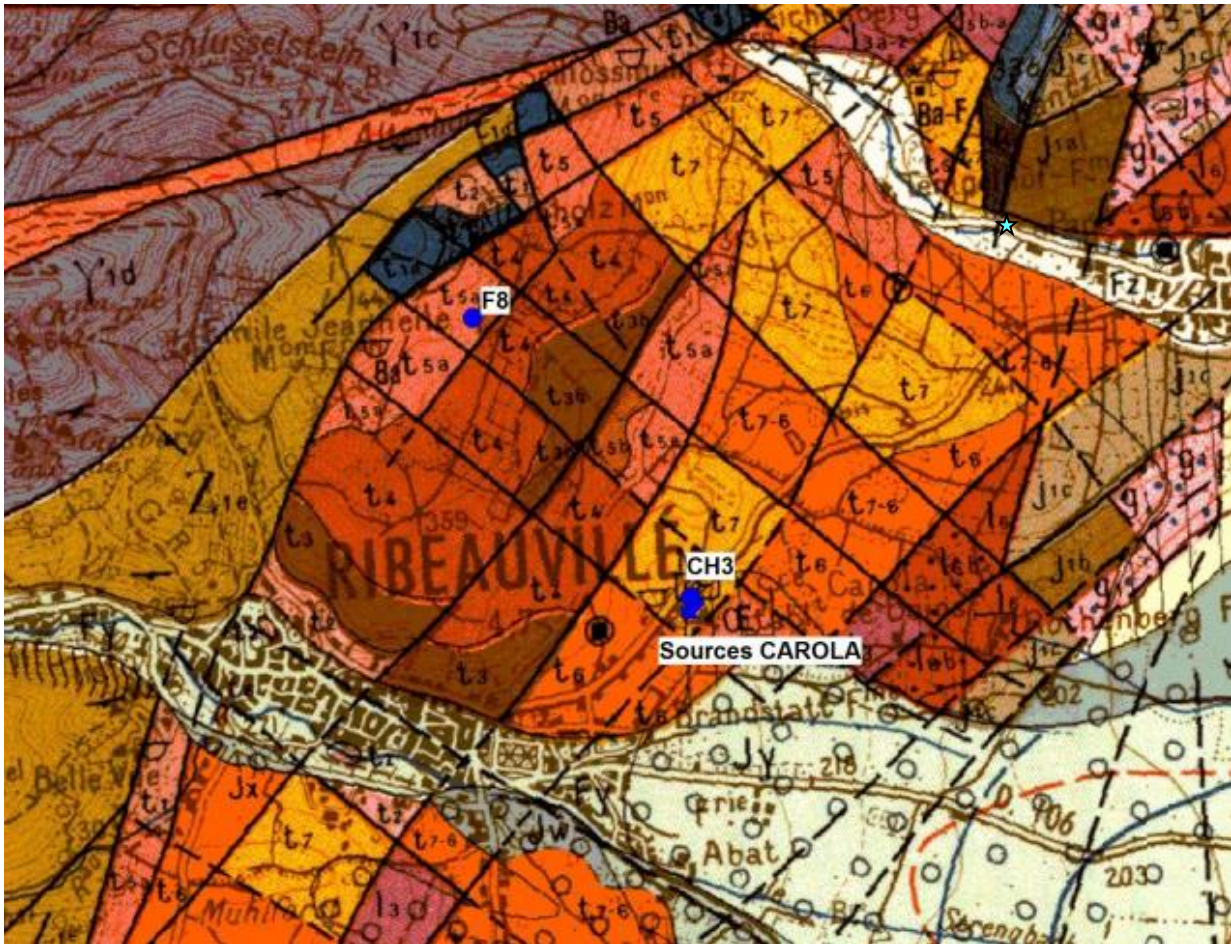
Figure 3: General map of the aquifer in the Ribeauvillé region

The bedrock of this region is the crystalline bedrock. The following figure shows the geology map.

The geological formations found in this sector are the following, from the most recent to the oldest:

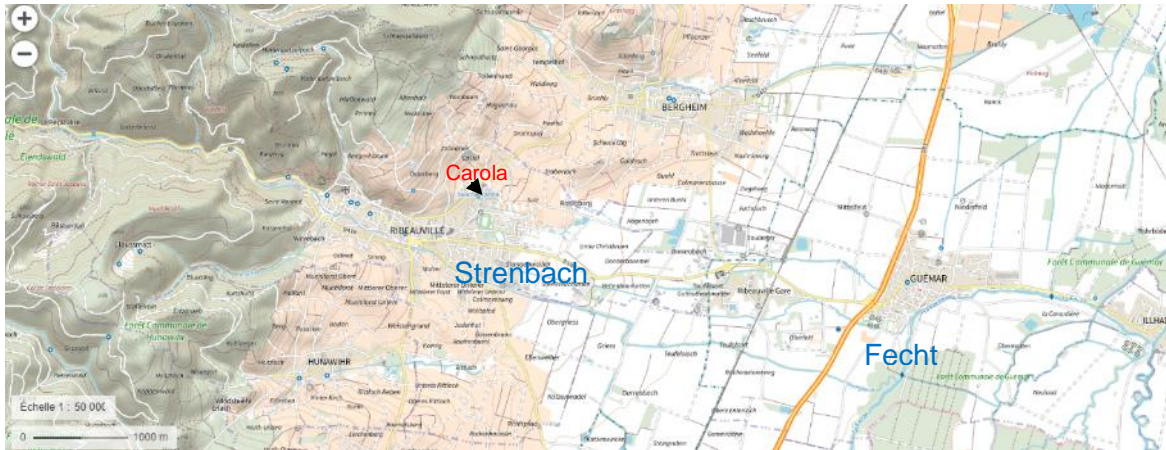
Figure 5: map of the surface water body on Vesdre catchment

The site is located in the left bank of the river 'Strengbach' which flows through the Ribeauvillé town. This river length is around 17.2 km and is an affluent of the river 'Fecht'. A small river, the Muehlbach, flows just in the south of the site; there is small ponds downstream of this river.

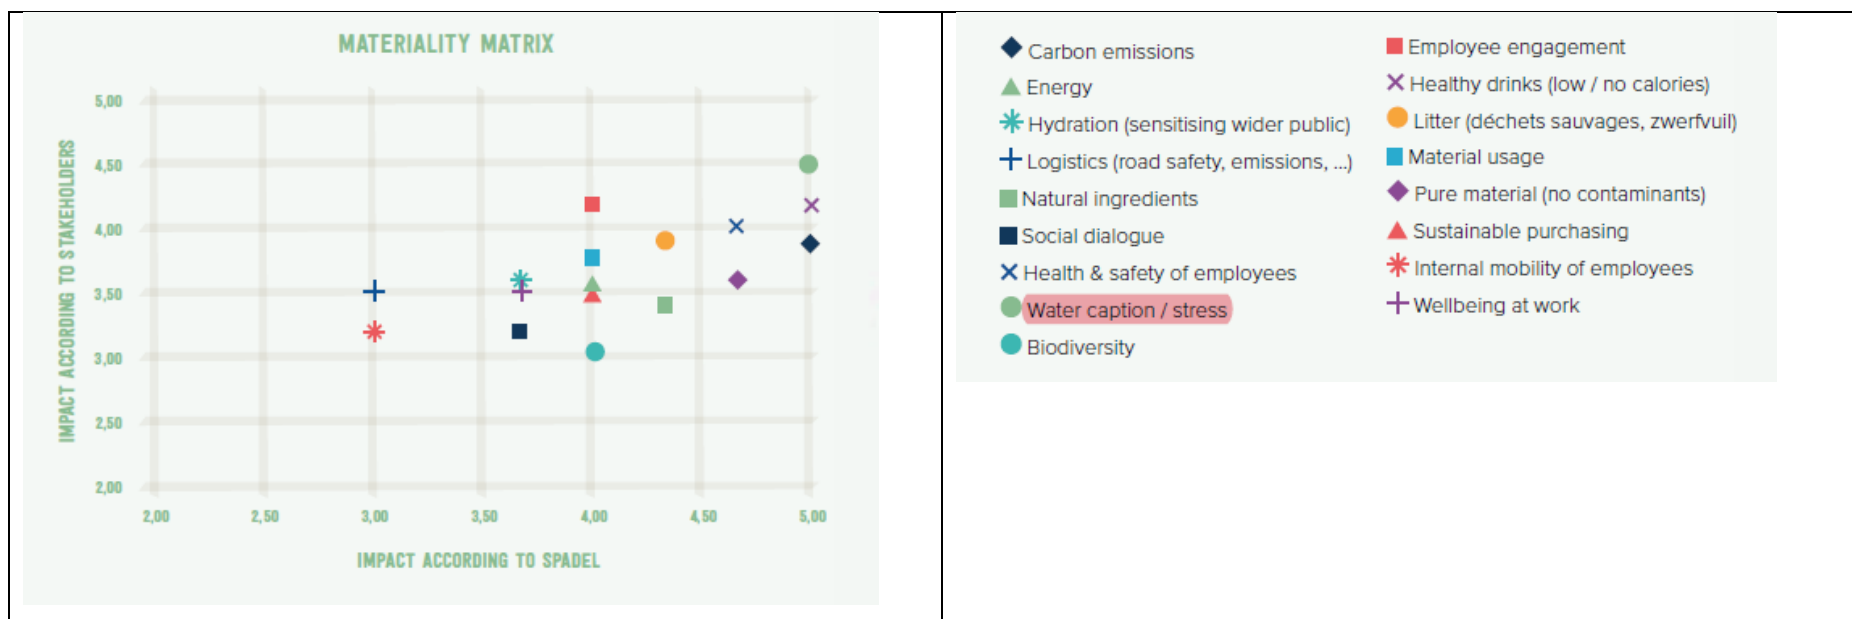
Spadel has developed a matrix to identify the shared environmental challenges and ranked them according to their impact. Reasons for ranking were provided together with reasons why the challenges are to be considered priorities for both stakeholders and the site.

Below, the matrix summarizes the identified shared challenges including water challenge.
