Alliance for Water Stewardship Assessment Report

Prepared for DEVIN JSC (AWS-000424)

Prepared by: SGS

Date: May 19, 2022

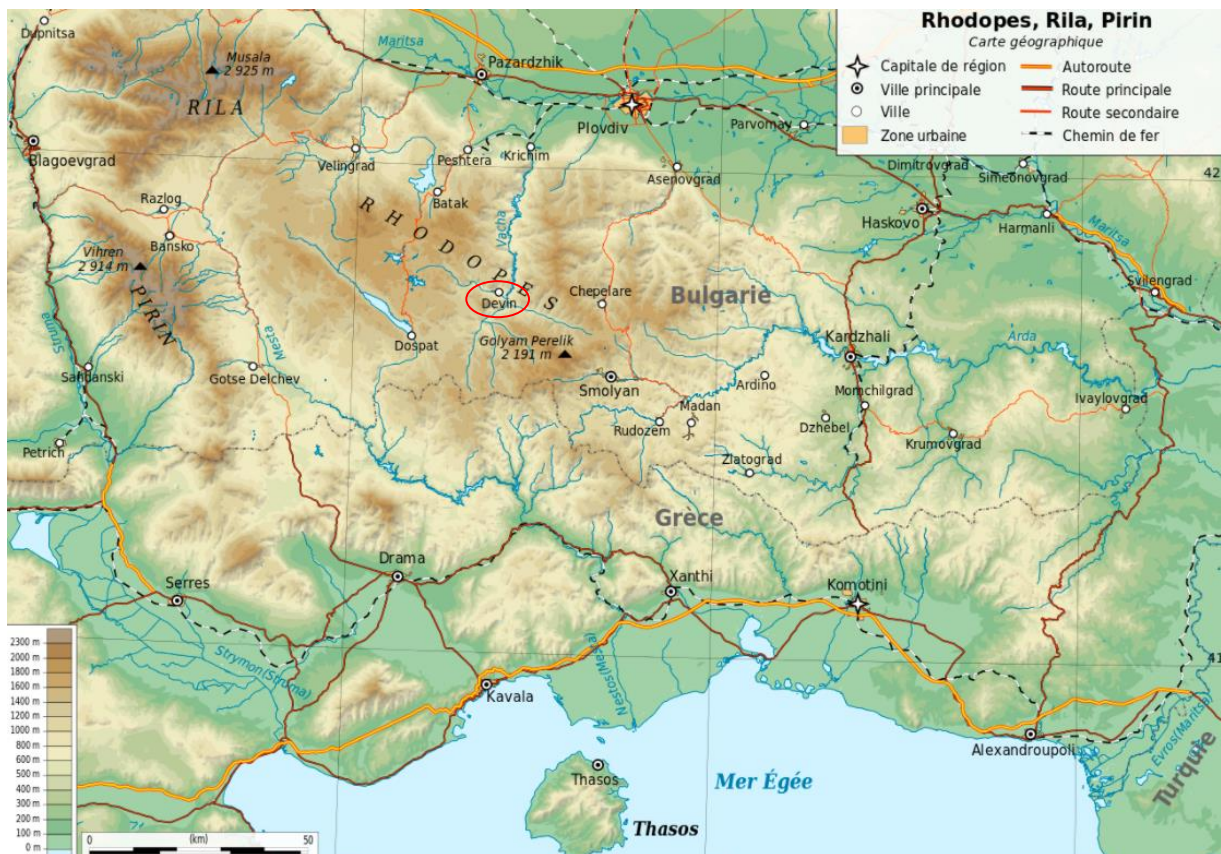
Figure 2: topographic map of Rhodopes

The topography is mountainous: the city of Devin is located in the Rhodopes mountain massif, with peak around 1.500-2100 m; the highest peak is the Goljam Perelik (2,191 m).

The plant is located in a steep valley in the altitude of 735 m above sea level. Around the site, the peaks are around 1000-1200 m.
