CERTIFICATION REPORT

Alliance for Water Stewardship (AWS)

Audit Number: AO-000218

Site: **Nestlé Santa Maria Factory - Puebla, MX**
Address: Santa Maria Factory, 74100, Puebla, MEXICO
Contact Person: Miguel Angel Medina Ortiz
AWS Reference Number: AWS-000064
Site Structure: Single Site

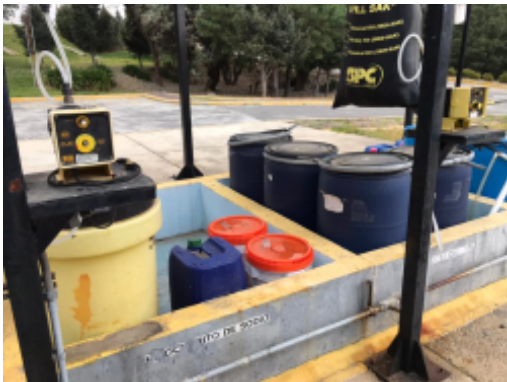
Site tour View of a section of its wastewater treatment plant
Audit Manantiales La Asunción 06.jpg

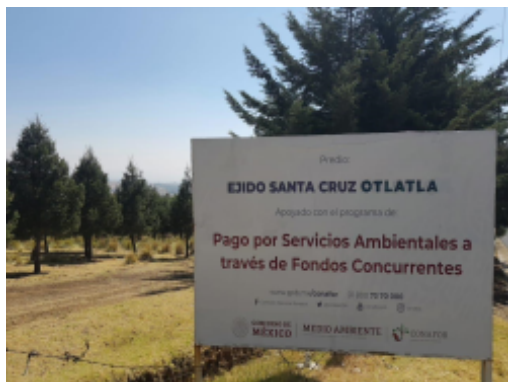
Audit Manantiales La Asunción 12.jpg

Board placed on the side of the road, informing about the area with payment for environmental services, located in the ejido of Santa Cruz Otlatla, in the background you can see part of the reforested area.

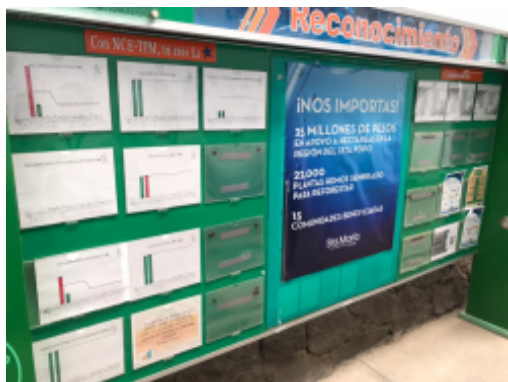
Audit Manantiales La Asunción 01.jpg

Internal communication board with information on the payment for environmental services programme.

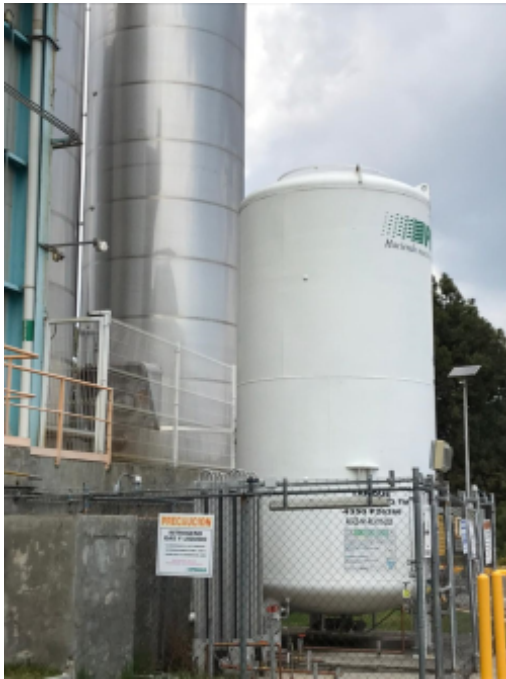
Audit Manantiales La Asunción 05.jpg

Tour of the factory: shows two tanks for the storage of inputs used in production.

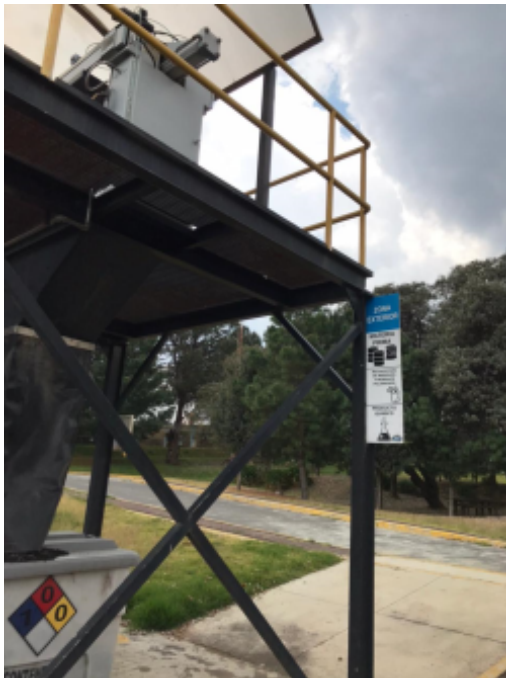
Audit Manantiales La Asunción 07.jpg

Site tour View of a section of its wastewater treatment plant

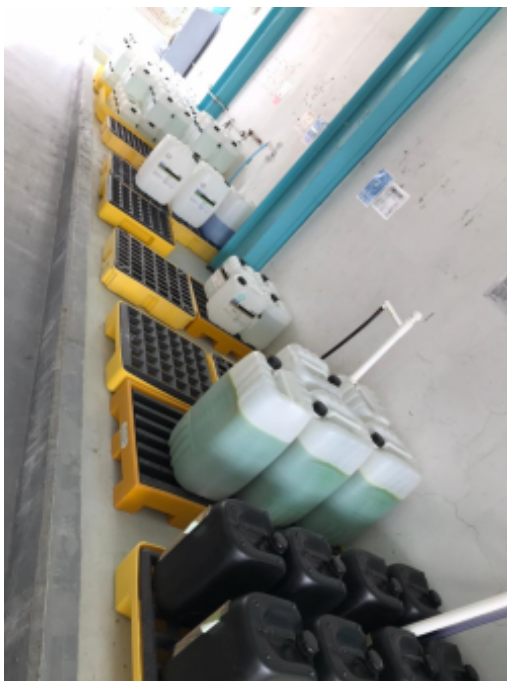
Audit Manantiales La Asunción 02.jpg

area of chemical substances used in production, it is observed that it is organised with bases that can contain accidental spillages.

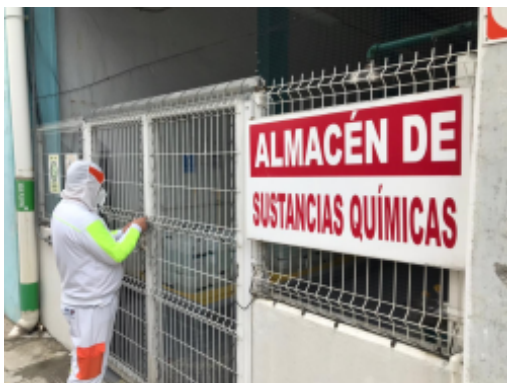
Audit Manantiales La Asunción 04.jpg

Enter the chemical area, access is restricted and the use of protective equipment is mandatory.
