CERTIFICATION REPORT

Alliance for Water Stewardship (AWS)

Audit Number: AO-000283

Site: Nestle Hellas Single Member S.A- Korpi factory

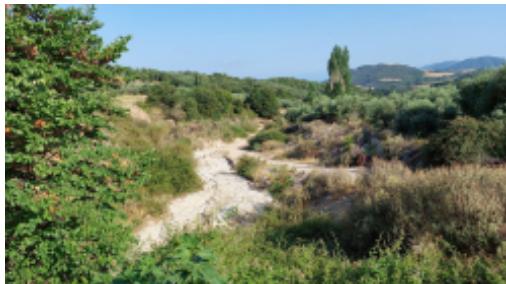
Next to the site, a dry riverbed is located, and a valley of a dry stream where the site's wastewater gets discharged into (not continuously). The small stream's valley leads to the dry river bed, and this dry river bed leads further downstream into Giourgia (yourya) and Voutoumias. The dry river bed has not had any water flow for many years - all water flows are underground. Any rainwater or the site's wastewater discharge infiltrates the stream bed. Therefore the surface water catchment is not really relevant for this site.

Dry river bed that is the recipient of the site's treated wastewater effluent and the stormwater
Dry river bed2.jpg

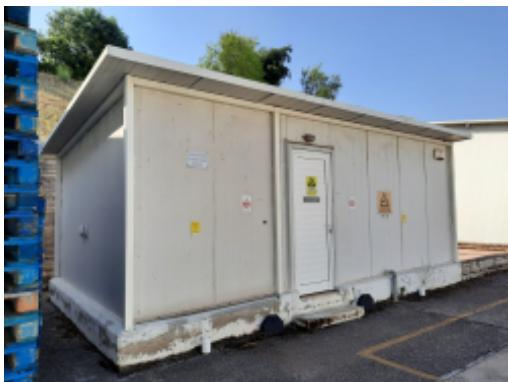
Well.jpg

Photos of the site from the road, one of the existing wells, a new well that's been drilled but is not yet connected to the site, site's wastewater treatment facility, dry river bed that is a recipient of the site's treated effluent (discharged sporadically) and stormwater, and Monastiraki springs - one of the IWRAs.

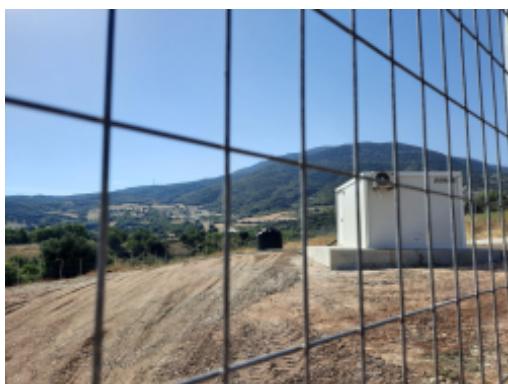
New well not connected to site yet.jpg

The site draws its water from groundwater aquifers located in Korpi synclinal groundwater sub-system. A new well has been drilled (but is not yet connected to the site) that reaches Jurassic sub-system. As the region is karstic, these sub-systems connect with other sub-systems, including Korpi anticlinal kakirite sub-system where the wells of the municipality are located. All these sub-systems fall within the Monastirakiou groundwater system and Vonitsa-Voulkaria groundwater system - those are groundwater bodies identified for the implementation of the EU Water Framework Directive, for which public data on quantitative and ecological status is available.
