CERTIFICATION REPORT

Alliance for Water Stewardship (AWS)

Audit Number: AO-000197

Site: **San Pellegrino: Bergamo**

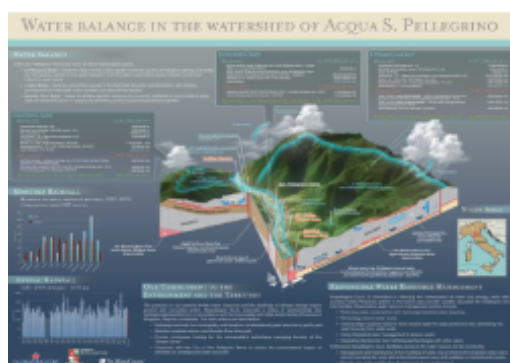
Water Balance in the Watershed of Acqua S Pellegrino.png

Comment	<p>The catchment water balance with precipitation, point source flows, subsurface flow runoff, hydrogeological characteristics and ET data were provided for the San Pellegrino Spa includes the three hydrological basins. Including the data summary of these three hydrological water balances. (from Model My Watershed Multiyear Model)</p>
