CERTIFICATION REPORT

Alliance for Water Stewardship (AWS)

Audit Number: AO-000437

Site: **BAT Honduras (Tabacalera Hondureña S.A.)**

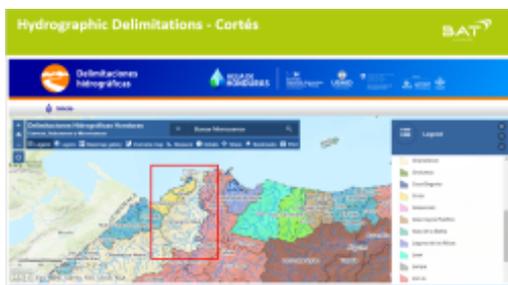
1.1_RegionesHidrologicasRelevantes_Cortés_Imagen2 (1).PNG

The alluvial aquifer system of the municipality of San Pedro Sula, to which the lower zone of Cofradía and Naco belongs, is located within the graben created during the post-cretaceous in various stages and filled by the products of erosion of the surrounding heights.

The lower part of the basin is the one with the greatest potential for the exploitation of the underground water resource, whose alluvial aquifer has thicknesses of over 80 m as it deepens.

The contribution that the upper part of the Manchagua basin makes to the alluvial aquifer that is formed in the lower part is currently limited due to the degradation of the land in the basin. In addition, the natural effect that the slope and the soils (fine silts and clays from the shales) have in reducing infiltration and subsequent recharge to the aquifer is also limited.

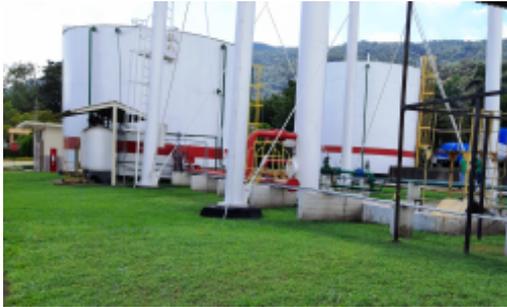
green areas within the perimeter of the site identified as IWRAs.
20221128_112241.jpg
