# CERTIFICATION REPORT

## Alliance for Water Stewardship (AWS)

Site: **Nestlé Waters Lebanon: Barouk Ain Zhalta**

Audit Type(s): Re-Certification Audit

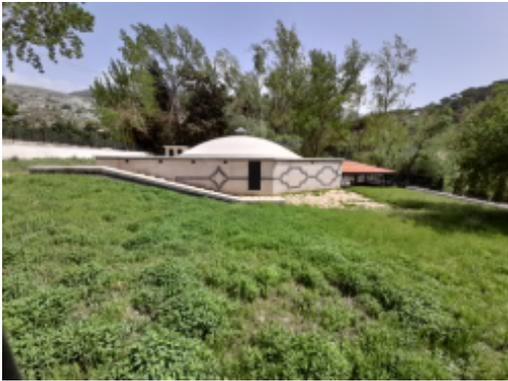
AZ Barouk spring house.jpg

Comment The site conducts water testing (for free) of numerous water sources in the catchment and have proactively instigated projects to improve water access to the public, particularly at the Barouk spring. The Barouk site offers access to clean and managed water for the public, which the WSAS team observed being utilised by the public.

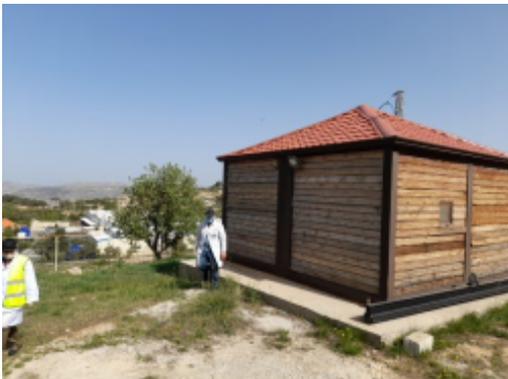
AZ Off-site well.jpg

**Comment** The on-site IWRA consists of the on and off-site wells, which are both situated on land leased by NW Lebanon. They have not been defined as on-site IWRAs by the site, nor mapped as such. The site does utilise a 'Well Maintenance - Assessment Tool' spreadsheet for each well, which has been developed by Nestle for use by all their sites. The Well Maintenance tool can be used to demonstrate that the site understand the condition of their on-site IWRAs
