#### Alliance for Water Stewardship (AWS)

Audit Number: AO-000343

Site: **PT Hanjaya Mandala Sampoerna Tbk** Address: Jalan Raya Surabaya - Malang KM 51.4, 67161, Sukorejo - Kab. Pasuruan, INDONESIA Contact Person: Amanda Hadi IsTianti AWS Reference Number: AWS-000116 Site Structure: Single Site

Audited Service(s): AWS Standard v2.0 (2019) Audit Type(s): Re-Certification Audit Audit Start Date: 2022-Oct-24 Lead Auditor: Rizwan Masood

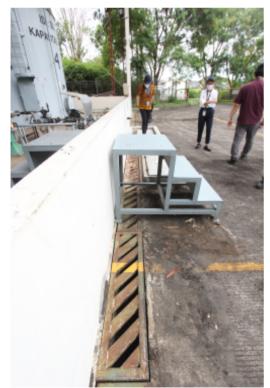
fuel tank area2.JPG

Comment	Site has identified the chemicals and fuels as potential sources of pollutions. Also, site has implemented best practices to avoid any contamination of water and soil i.e. secondary containment. spillage kits and access control.	
	Finding No: TNR-002911
