CERTIFICATION REPORT

Alliance for Water Stewardship (AWS)

Audit Number: AO-000569

Site: **Abbott EPD Chile - Santiago**
Address: Calle Carrascal 5650, 04566-905, Santiago, CHILE
Contact Person: Maria Carolina Gil
AWS Reference Number: AWS-000514
Site Structure: Single Site

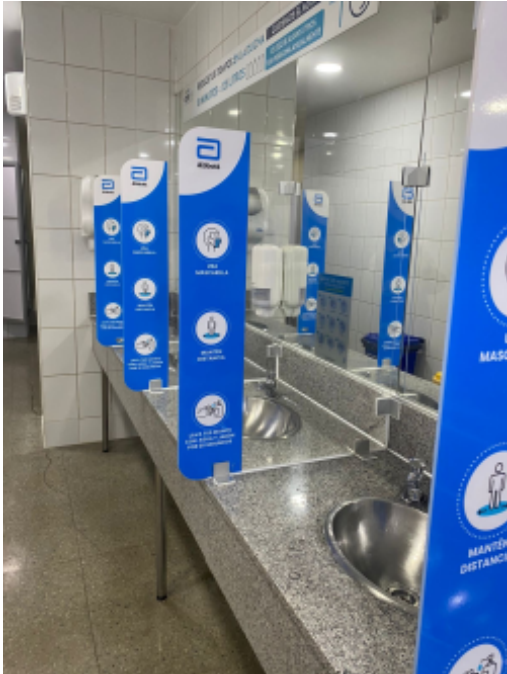
WASH Planta 01.png

Comment During the tour of the site, it was observed that the site has restrooms and dressing rooms (with showers) for men and women. All of the facilities are very clean and in the production area the personnel perform with a high level of cleanliness.
It was possible to observe that at least on each floor or major site there are drinking fountains where workers can drink water, as well as in the canteen.
There is also a nursery.
The aforementioned information was validated during interviews with workers.
