# CERTIFICATION REPORT

## Alliance for Water Stewardship (AWS)

Audit Number: AO-000615

Site: **BAT Serbia - Vranje**

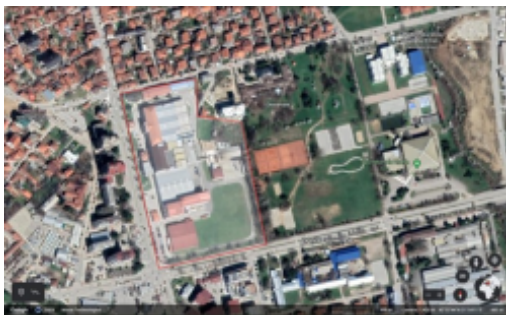
Site map.jpg

There are two wells on the main site's plot, but they are not used. All the site's water supply comes from the municipal water service provider Vodovod. All wastewater is discharged to the municipal wastewater collection network and is treated in the new municipal WWTP.

Corrective action:	<p>Update exiting map to show stormwater discharge from site to discharge water body.</p> <p>Update exiting map (site boundaries) to show agricultural land next to warehouse in Suvi Do and indicate location (north) scale.</p>

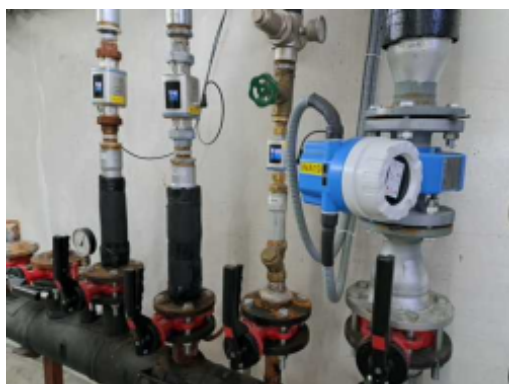
Metering devices.jpg

Comment	The following best practices on water balance on site were implemented: <ul style="list-style-type: none"><li>- installation of additional water meters to be able to understand water use at department level;</li><li>- daily tracking of water use;</li><li>- daily leakage checks;</li><li>- recycling of sanitary tap water in toilets and using it for flushing toilets.</li></ul>	
<b>3.9.3</b>	<i>Actions towards achieving best practice, related to targets in terms of water quality shall be implemented.</i>

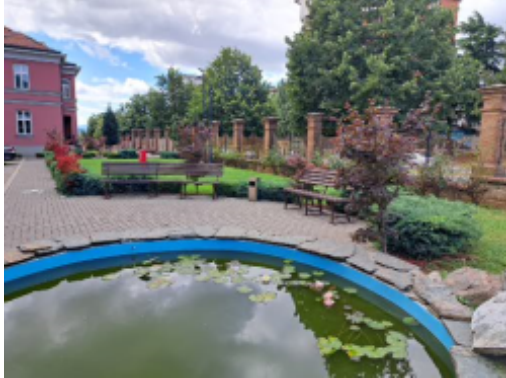
Little pond.jpg

Findings:	As the small pond in the rest area of the site grounds appears to be important for the enjoyment of the employees, it could be identified as an on-site IWRA, as it is already regarded as such by the employees. Also, site should include a description of their status including Indigenous cultural values.
Finding No:	TNR-005858
Checklist Item No:	1.3.7
Status:	In Progress - CA plan approved
Finding level:	Minor
Due date:	2024-Sep-01
Checklist item:	Annual water-related costs, revenues, and a description or quantification of the social, cultural, environmental, or economic water-related value generated by the site shall be identified and used to inform the evaluation of the plan in 4.1.2.
Findings:	Value generated by the site is noted in the water stewardship plan but it is noted in a very generic way (e.g. 'decrease water consumption', 'contribute to good water quality in the catchment'), which cannot really inform the evaluation of the plan.
