CERTIFICATION REPORT

Alliance for Water Stewardship (AWS)

Audit Number: AO-000667

Site: **Tyson Fresh Meats - Amarillo Plant**
Address: Farm Road 1912 Highway 66 East, 79120, Amarillo, Texas, UNITED STATES
Contact Person: Brittany Craig
AWS Reference Number: AWS-000473
Site Structure: Single Site

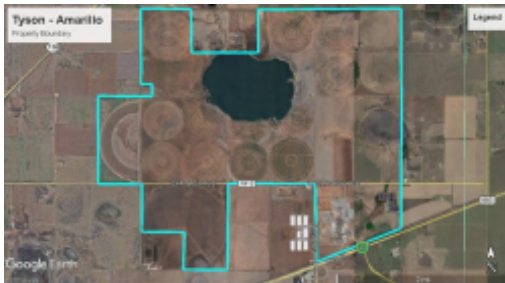
Site Boundaries.jpeg

The Amarillo Complex has operated a beef slaughtering, processing, and rendering facility since 1974. The facility process was expanded by adding the tanning process in 1992.

The water is supplied by the City of Amarillo. A wastewater plant is also a big part of the plant, it has 6 lagoons. Once the water has been treated from the anaerobic lagoons it is then sent to the Playa Lake. From there the process water is reused by plumbing water into center pivots and irrigated on Tyson's farmland. A service center (PBX), cold storage, and administrative offices are also located at the Amarillo Complex.
