CERTIFICATION REPORT

Alliance for Water Stewardship (AWS)

Audit Number: AO-000778

Site: **Abbott CRM Sylmar**

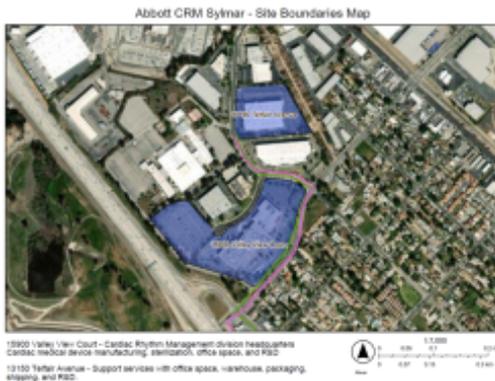
Abbott CRM Sylmar site boundaries.png

The Site is divided in two buildings, Telfair and Valley View. Telfair host offices and stores a small part of chemical and other hazardous materials and Valley View host offices, manufacture operations and stores the majority of chemicals and other hazardous materials. Therefore most of the water related infrastructure is located in Valley View. Part of the manufacturing activities is polishing some of the metal components of the final products, the water produced is consider categorical by the Environmental Protection Agency and therefore is handled separately.

To provide optimum environment for its 1,300 employees and its business, the Site requires: humidifiers, dehumidicators, reverse osmosis systems that supply water to chillers, cooling towers and the "water loops" where water passes through UV, micro and endotoxin filters before entering the manufacturing process. The total under roof footprint of the Site is 450,000 square feet.
