CERTIFICATION REPORT

Alliance for Water Stewardship (AWS)

Audit Number: AO-000652

Site: **BAT Germany - Bayreuth**
Address: Weiherstraße 26 95448, Bayreuth, GERMANY
Contact Person: Andreas Mix
AWS Reference Number: AWS-000485
Site Structure: Single Site

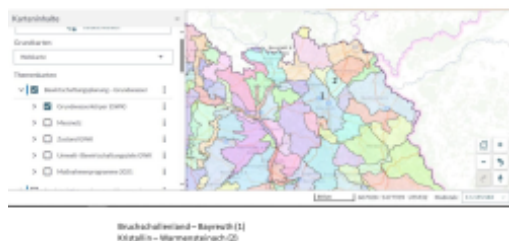
Groundwater bodies within the Rhein catchment where wells are presumably located.JPG

Figure 2: Groundwater bodies within the Rhein catchment where wells are presumably located

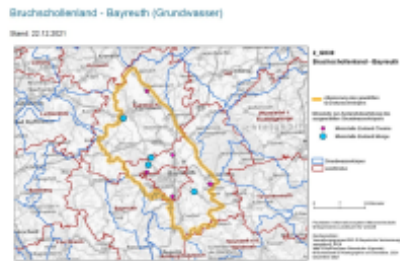
Bruchschollenland – Bayreuth.JPG

- Bruchschollenland - Bayreuth (1)
- Kristallin - Warmensteinach (2)

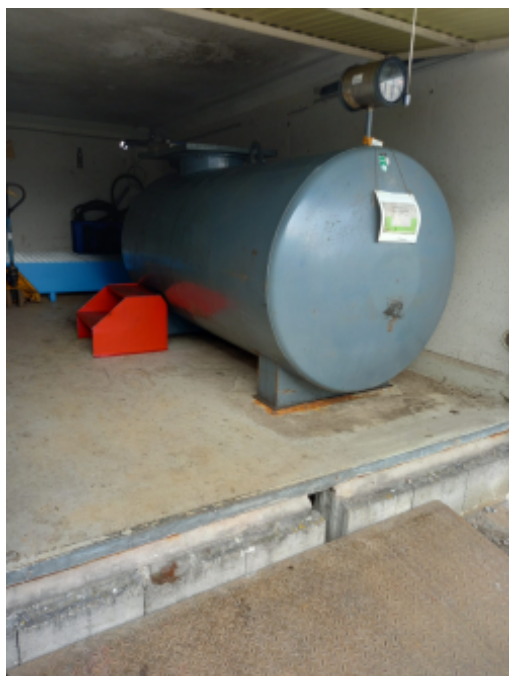
Waste Oil Tank - no spill kit.jpg

Another action implemented by the site for water quality was in re-equipping and purchasing of additional spill kits on-site to mitigate the risk of contamination on site with hazardous materials / chemicals in case of spillages .
