AUDIT REPORT

Alliance for Water Stewardship (AWS)

Audit Number: AO-000662

Site: **CocaCola - Planta de Concentrados Mexico**

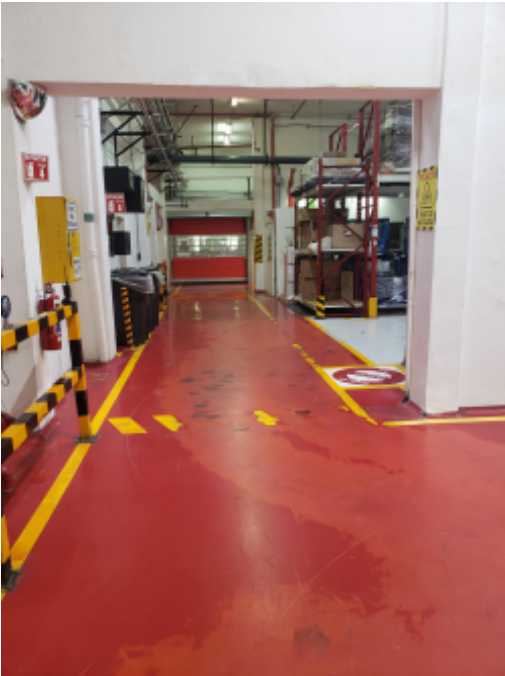
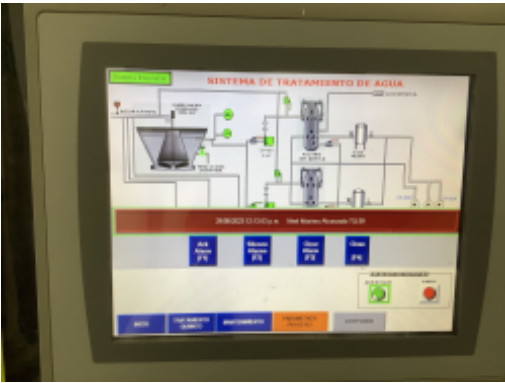
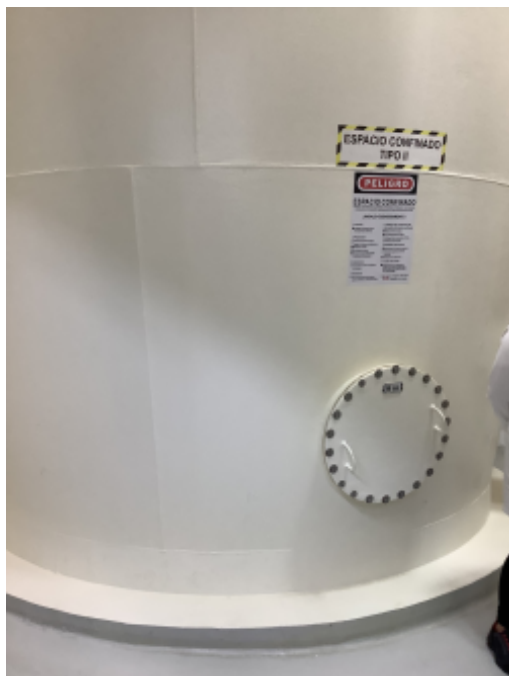
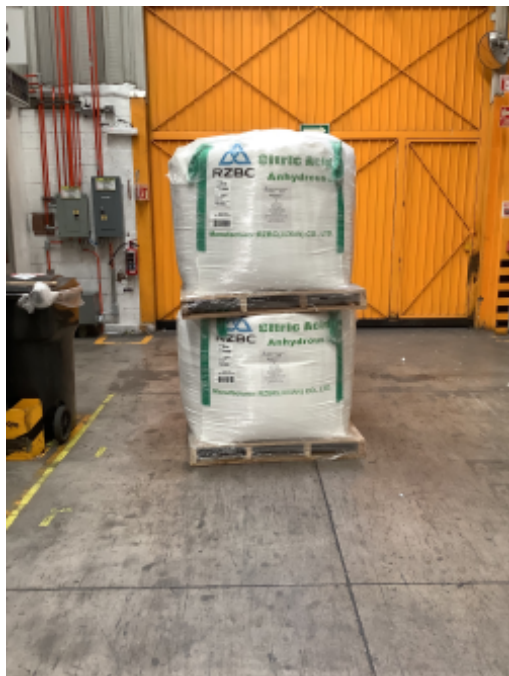
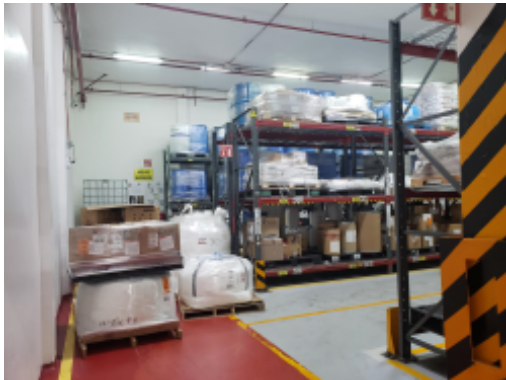
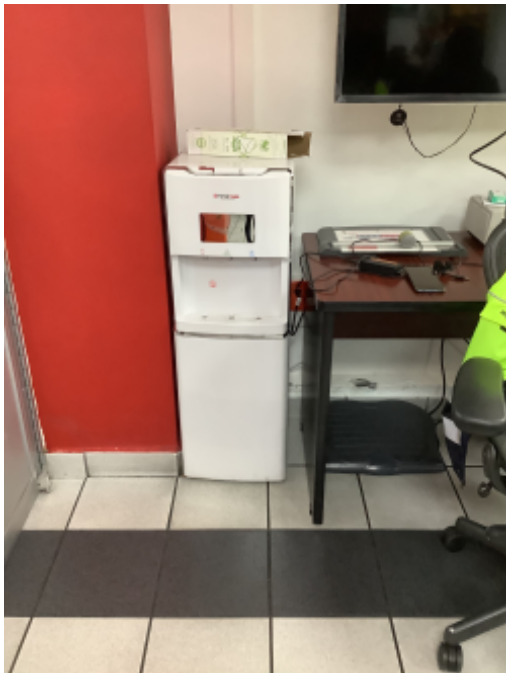
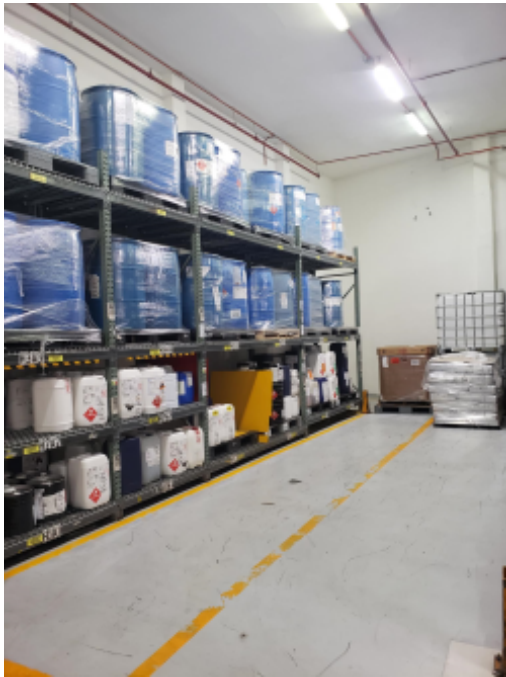
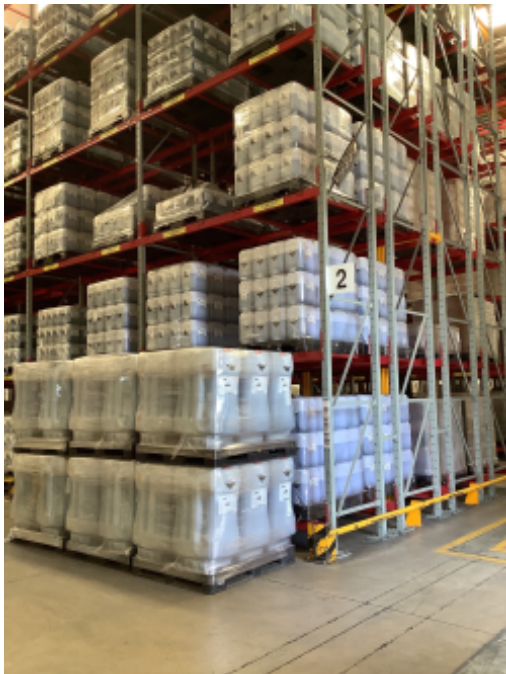
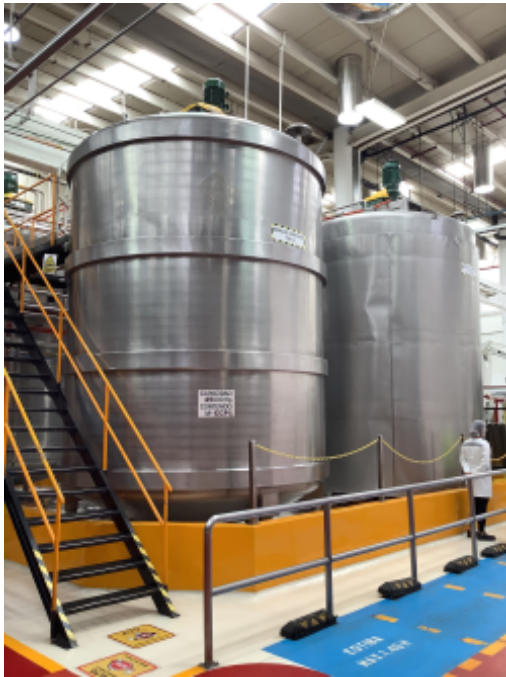
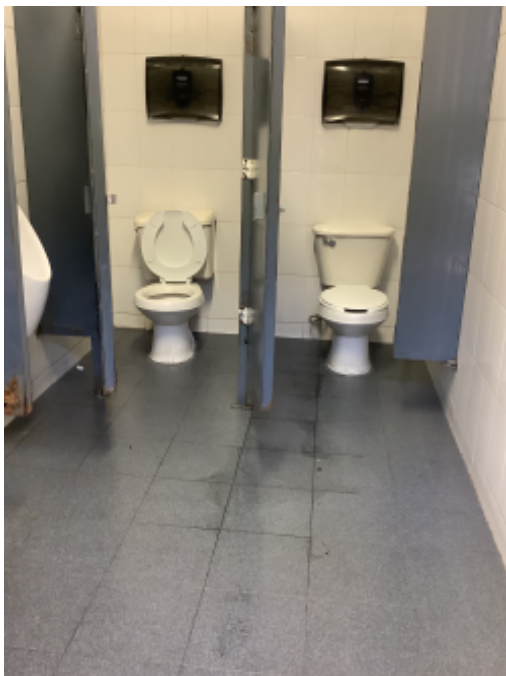
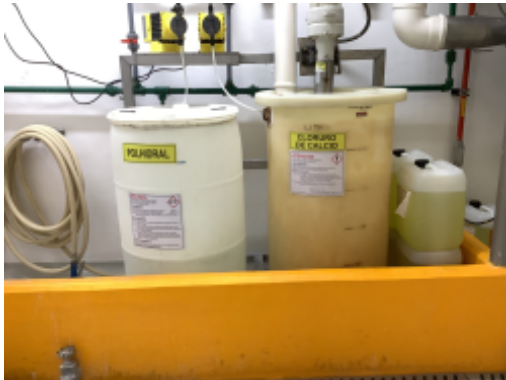
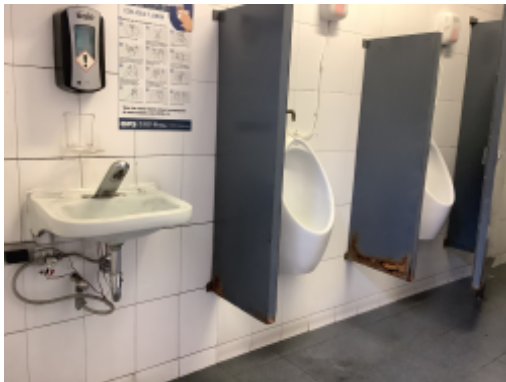
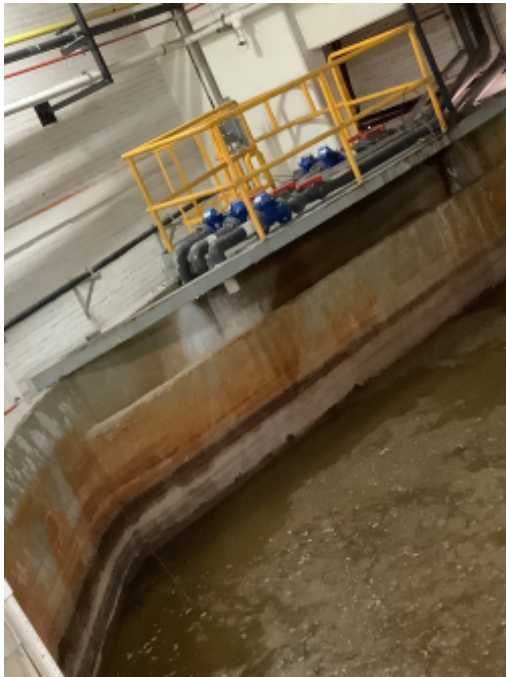
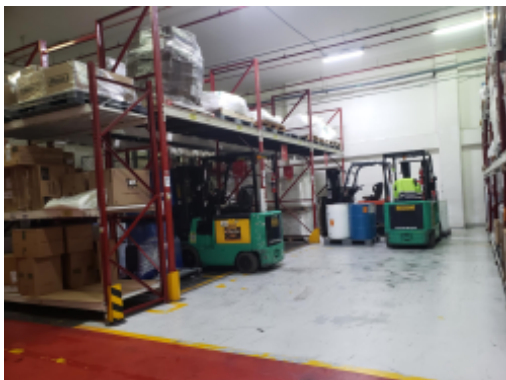
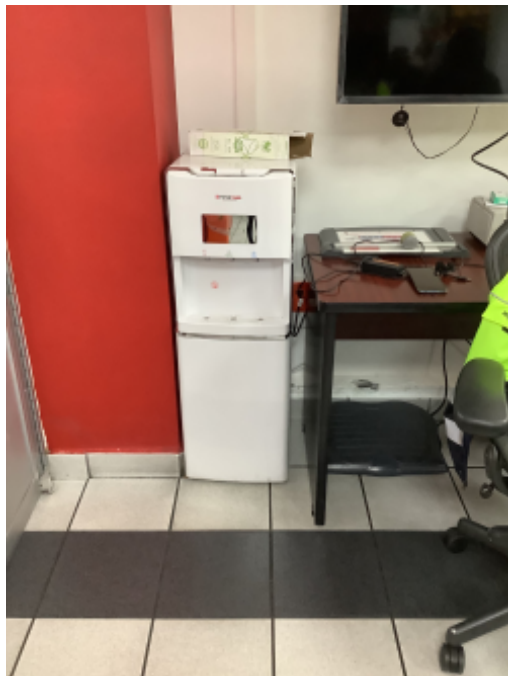
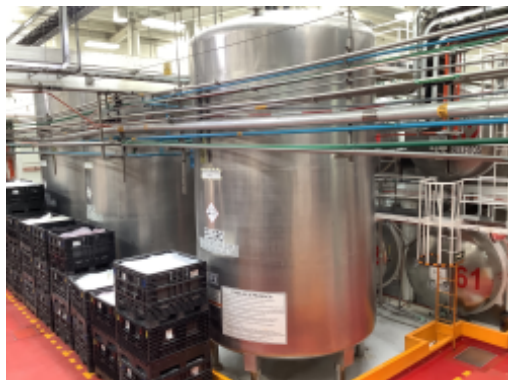
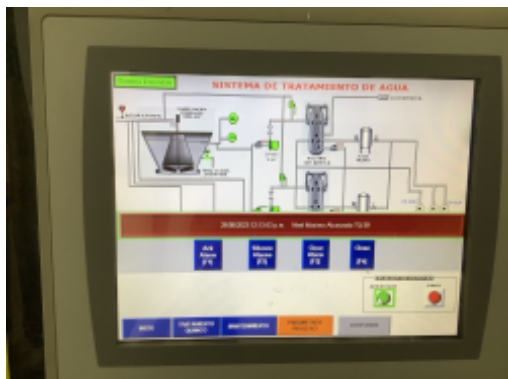
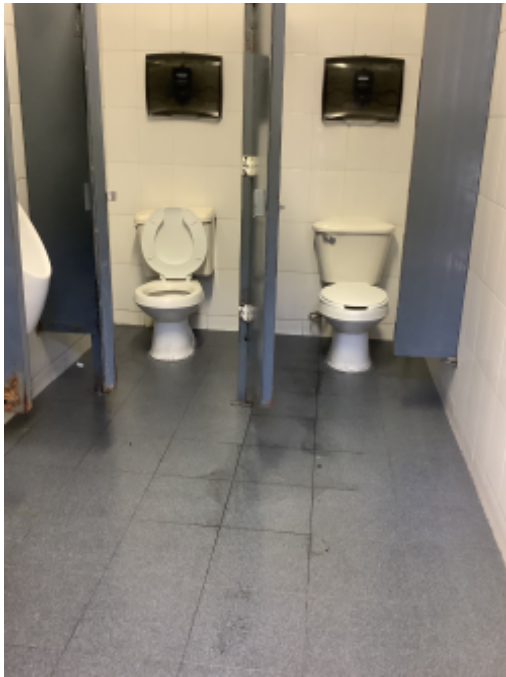
During the tour of the site, the production area, WWTP, finished product storage, sanitary chemical storage and changing rooms were visited.
