# AUDIT REPORT

## Alliance for Water Stewardship (AWS)

Site: **Philip Morris Polska S.A. ("PMPL SA")**

Audit Type(s): Re-Certification Audit

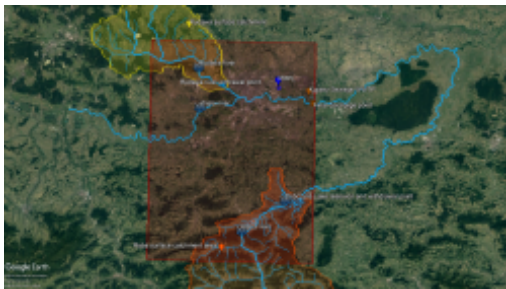
PMPL catchment area & physical scope identified by the site.jpg

For the identification of the catchment, the site identified sub-catchments of the sources of water up to the points of water withdrawal on the Raba and Rudawa rivers, and a rectangular area around the site as its physical scope, encompassing the municipal WWTP as well as its discharge location. However, the rectangular area is not a catchment. It should be noted that for the collection of data and information on the catchment, the site mostly considered more than just these two sub-catchments and the rectangular area, i.e. it considered a wider upper Vistula catchment. However, the map of the upper Vistula catchment was not provided.

| Corrective action: | <p>The site will identify and include the upper Vistula catchment area in the catchment area map currently in place.</p> |

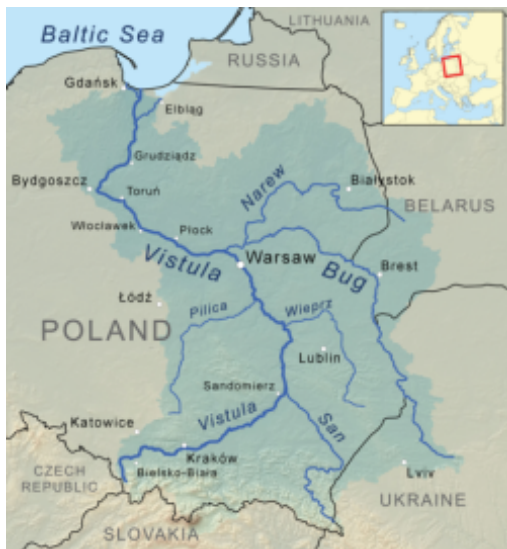
Vistula river catchment with Krakow in the southern part.png

The facility is located in the middle of the upper part of the Vistula (Wisła) catchment. The Vistula river catchment is very large but the river can be divided into three parts: upper, from its sources to Sandomierz; central, from Sandomierz to the confluences with the Narew and Bug; and bottom, from the confluence with the Narew to the sea.

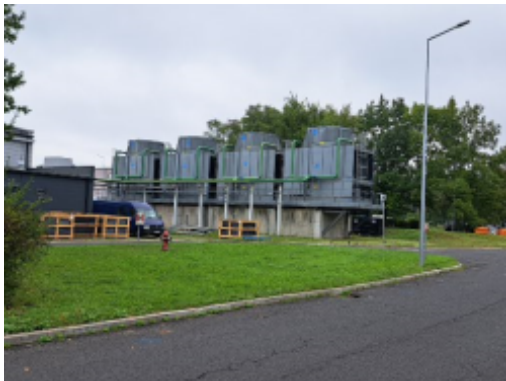
Cooling towers.jpg

| Findings: | <p>A closer examination of the metered flows and estimations indicates that wastewater volume is likely a bit overestimated because adiabatic cooling is not included in the calculation of what evaporates.</p> |

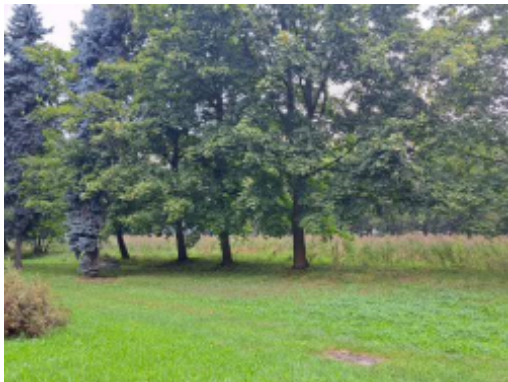
Mature tree and wild meadow area on site grounds.jpg

| Comment | <p>The following initiatives were implemented to maintain or enhance IWRA's:</p> <ul style="list-style-type: none"> <li>- Dlubnia river clean up event with NGO EcoTravel Foundation.</li> <li>- On-site green areas with mature trees are also essentially regarded as an on-site IWRA. Flower meadows were created next to the mature trees to improve the biodiversity and resilience of the on-site green areas.</li> </ul> <p>Further IWRA clean-up events were planned for the days just after the audit in Nowa Huta meadows, the IWRA next to the site, and for mid-October in Dlubnia river.</p> | |
