CERTIFICATION REPORT

Alliance for Water Stewardship (AWS)

Audit Number: AO-000629

Site: **Philip Morris Manufacturing Senegal**
Address: KM 11.5 Route de Rufisque, 50596, Dakar, SENEGAL
Contact Person: Moustapha Wele
AWS Reference Number: AWS-000571
Site Structure: Single Site

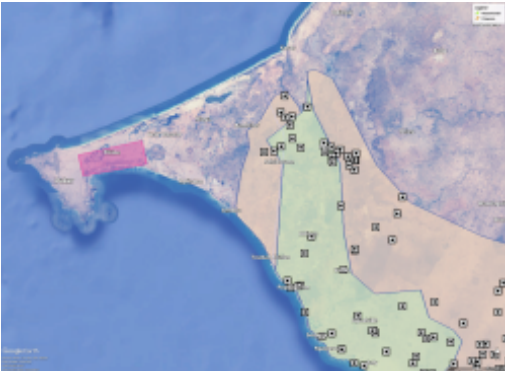
DakarBoreholes.jpg

The site obtains its water from two separate catchments, namely the deeper Maastrichtian and more recent Palaeocene aquifers of the Sebikhotane ground water catchment and the Lake Guiers surface catchment area. The Sebikhotane ground water catchment is located between 22km and 115km to the south-east of Dakar and the Lake Guiers surface catchment area in the northern part of Senegal, on the left bank of the Senegal River, between 134km and 334km to the north-east of Dakar . The site itself is located in the Thiaroye sub-catchment within the City of Dakar, outside of the Sebikhotane and Lake Guiers catchments.

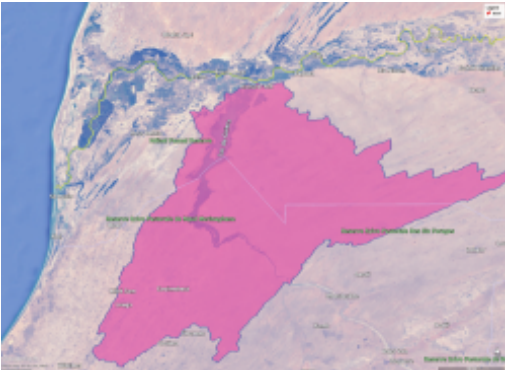
BasinGuiers.jpg

According to a Senegal water resources profile overview issued by USAID, invasive aquatic plant growth has reduced the flow and oxygenation of surface waters and is impacting Guiers Lake. Aquatic plants have reduced water quality, slowed water velocity, and increased siltation, which have disrupted ecosystems and impacted agriculture, fishing and animal husbandry. Agricultural runoff has caused eutrophication and plant growth in the Guiers Lake surface water catchment area.

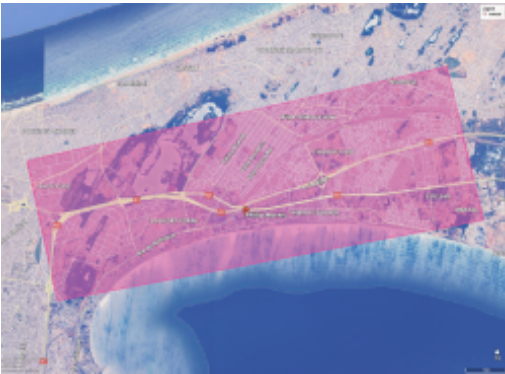
PMMSN area Physical Scope.jpg

The site operates a tobacco manufacturing facility at km 11.5 Route de Rufisque in the Pikine Ouest/Thiaroye Sur Mer area of Dakar, Senegal. The site occupies an area of 15,128 m2 approximately 300m north of the coastline of Baie de Hann.
