CERTIFICATION REPORT

Alliance for Water Stewardship (AWS)

Audit Number: AO-000823

Site: **Apple - Viborg Data Center**
Address: Blichers Alle 25, Tjele,, 8830, Viborg, DENMARK
AWS Reference Number: AWS-000628
Site Structure: Single Site

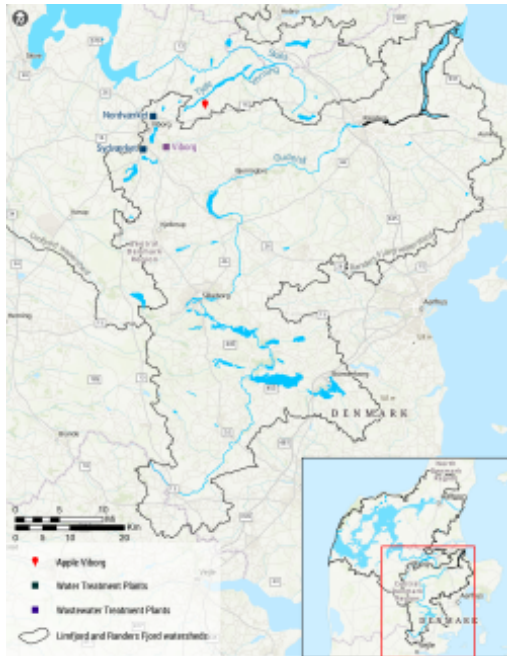
ViborgDK_WaterWastewaterTreatment_31May2023_(1).jpg

The local catchment where the site is located, this is the Limfjord catchment. It is also important to recognize the origin of the water sources (local groundwater) and the ultimate receiving waterbodies, the Nørreå River, a tributary to the Gudenå River, in the Randers Fjord catchment.

Groundwater is pumped by Viborg Vand from 12 wells at three spring sites, the most important for the utility being directly north of Viborg. Groundwater from this spring area is generally withdrawn from sand-gravel glacial deposits (Viborg Municipality, 2016c). The groundwater has some iron and manganese content that is treated before being pumped into the water distribution system. While the site lies at 47.5-59 meters above sea level, groundwater underlying the site lies at approximately 22.0-31.5 meters above sea level. The site is partly within an area with special drinking water interests, but outside catchments for local water treatment plants and sensitive action areas. The nearest catchment for a local water treatment plant is approximately 400 m to the northwest at Foulum Vandærk (Waterworks). This facility, which does not provide water to Apple, withdraws water from approximately 100 m below ground and is well protected by 30-40 m clay (Viborg Municipality, 2019).

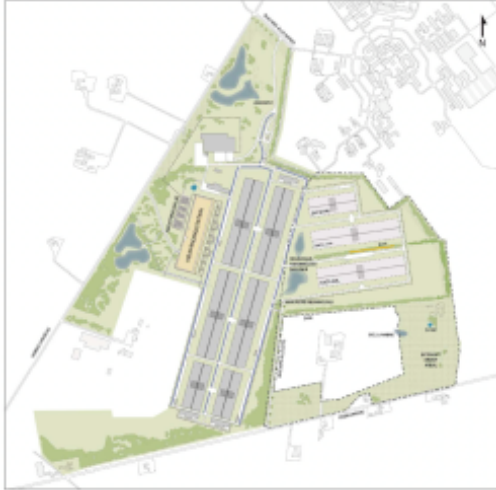
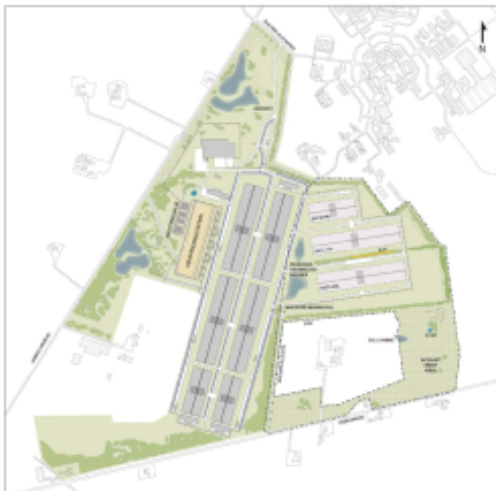
The Viborg Data Center is located in the Limfjord watershed, in the northern central part of the Jutland Peninsula in Denmark. The facility consists of one data center, four NDS buildings and administration/logistics building.

The property area is approximately 233 acres and the total building area is 48,000 square meters, the site location is within the Viborg Municipality, Denmark. The water supply is provided by Energi Viborg, with water received from the local aquifers in the Viborg region via 12 boreholes at three spring sites. All wells are located within the Randers Fjord watershed. The site receives one domestic and one technical water line. All incoming water is treated at the Nordværket and Sydværket water treatment plants and the site also collects rainwater for supplemental use on-site.

The discharge at the site is handled and treated by Energi Viborg, which flows from the site to the Viborg Central Wastewater Treatment Plant before being discharged to the Nørreå River, a tributary to the Gudenå River, within the Randers Fjord watershed. The site's stormwater discharges to two on-site ponds (infiltration and sedimentation) all stormwater is now stored onsite in the retention ponds and is no longer being discharged into Tjele A. This is within the Limfjord watershed, with the nearest surface water body to the site being the Tjele A.

The site is on a single water incoming line from EnergiViborg, and they are the only recipient. There are two sedimentation and filtration ponds (4 in total) and a paragraph three protected pond onsite (IWRA). The protected pond was pre-existing, but the storm water ponds were constructed by Apple during the construction phase. This was designed with the neighbouring industries in mind: University, business park and power station. Apple has purchased and owns all the land.
