WATER STEWARDSHIP ASSURANCE SERVICES

Alliance for Water Stewardship (AWS)

Audit Number: AO-000933

Site: Nestlé Waters Bahrain - AlManhal Water Factory Address: ALMUSALA , BLOCK 411 , ROAD 1161 , BUILDING 1493, MANAMA, BAHRAIN Contact Person: Noor Alaradi AWS Reference Number: AWS-000592 Site Structure: Single Site

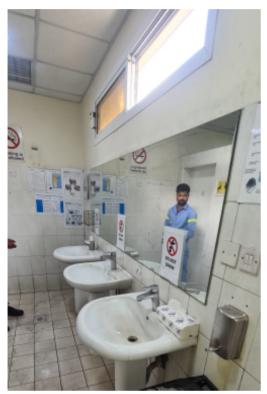
Hand Wash Area.jpeg

1.3.8	Levels of access and adequacy of WASH at the site shall be identified.	✔Yes
Comment	The site has adequate arrangements to ensure access to safe drinking water, sanitation and hygiene (WASH) for all workers. Site is also using a self-assessment tool for evaluating access to water sanitation and hygiene (WASH) at workplace. Update 2023 sheet is attache It covers the workplace facilities related to water supply, sanitation and hygiene.	
	Site has maintained separate toilets for males and females also evaluated the adequacy of number of toilets for each gender.

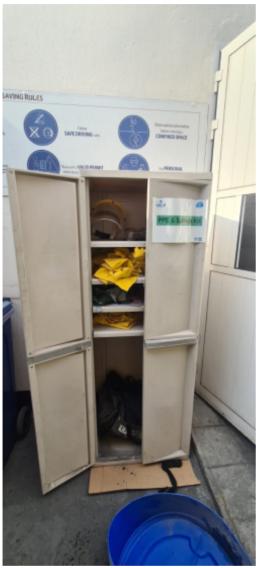
Spillage Kit.jpeg

1.3.1		✓es
Comment	Site has documented its emergency response plan which includes responses to water related incidents like Spill of chemicals/potential pollutants. Site also has response plan in case of wastewater treatment plant failure.
