CERTIFICATION REPORT

Alliance for Water Stewardship (AWS)

Audit Number: AO-000834

Site: **BAT Samoa**

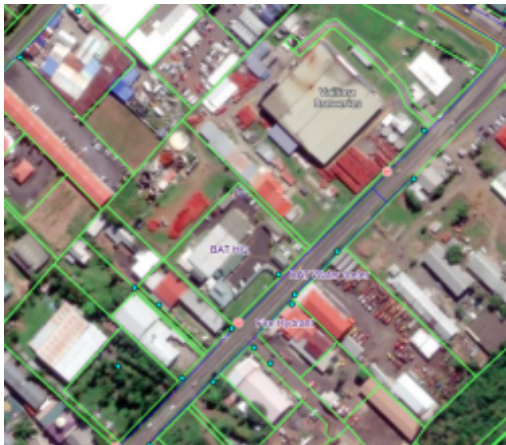
Imagem1.png

The Fuluasou Watershed is the catchment where the site is connected as this is the ultimate source of its water supply. The watershed is located in the north-central part of Upolu Island west of Apia, the capital and largest city of Samoa. Accordingly, it has an approximate measurement of 300 hectares and an altitude from sea level that varies up to 750 meters at the crater of Lake Lanotoo. The Fuluasou Watershed is accordingly the second most important source of water in Samoa which provides water supply to over 40,000 people between Apia and Satapuala near the Faleolo Airport including the Vaitele Industrial Area where the site (BAT Samoa) is located. The watershed has three main river branches where the water supply is tapped.

There is another catchment that the site affects, the final receiving body of the site's wastewater which is the Tafaigata Landfill. This landfill is categorized accordingly as a semi-aerobic landfill which has been developed since 2002 with the support of JICA (Japan International Corporation Agency). The landfill is located 10 kilometers west of Apia. It was described that the Tafaigata Landfill is equipped with leachate collection pipes, gas venting pipes, leachate ponds, etc. It has an approximate measurement of 30 ha that includes that landfill area, a sludge treatment facility, and a private recycling facility. It is accordingly managed by MNRE (Ministry of Natural Resources and Environment) of Samoa while a private contractor is sourced out for the day-to-day landfilling and soil covering onsite using heavy equipment/machinery.

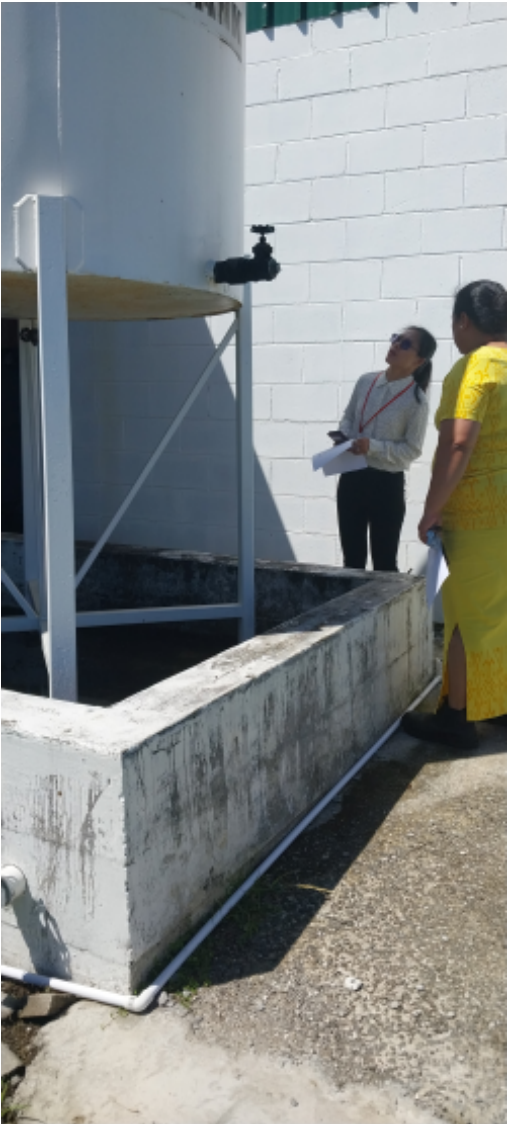
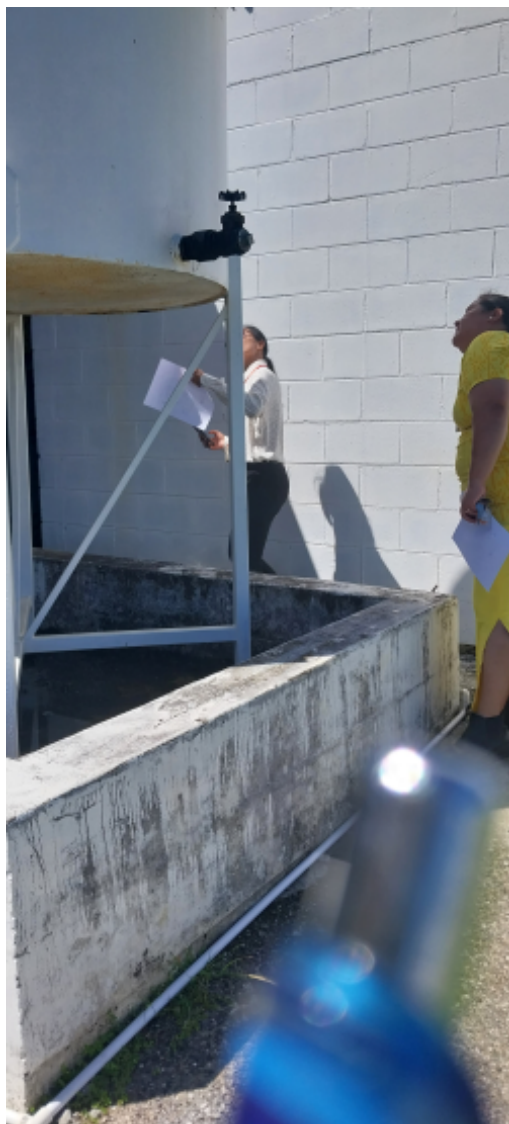
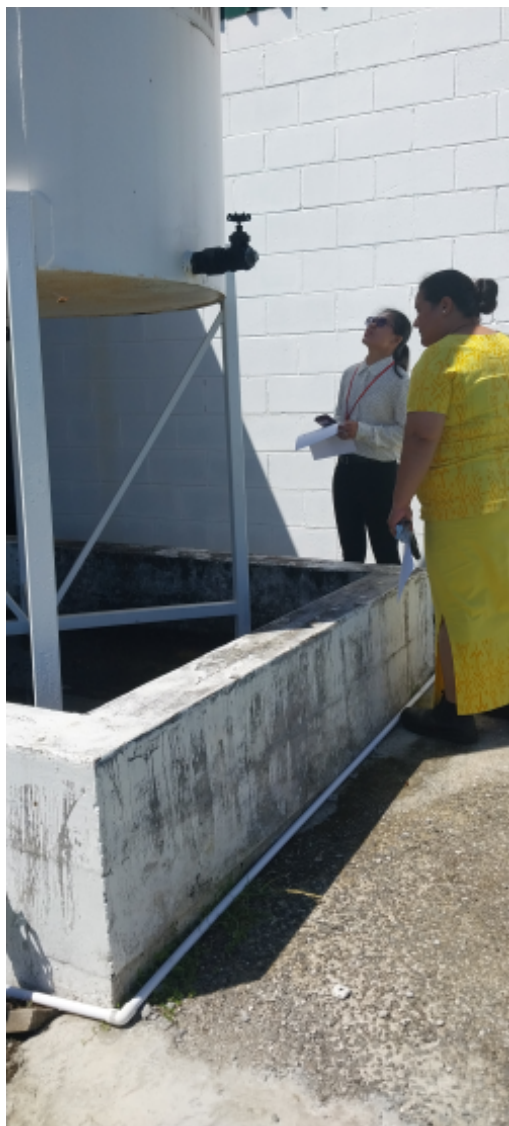
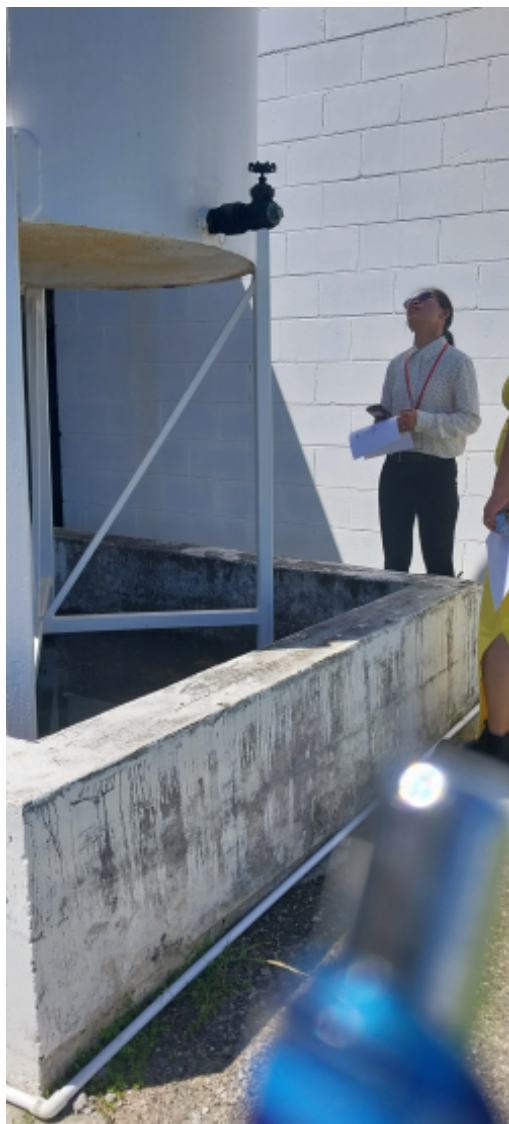
Fuel tank.jpg

The generator set area (two units were available in standby modes) can be included in the map as this area can also be a potential source of water pollution (near the fuel tank). Likewise, there were two used lead acid batteries stored within the area as noticed during the site tour. All possible sources of contamination, including chemicals used or kept on site, must be located and mapped.

A site tour was done from the Samoa Water Authority meter (water incoming supply) just outside the fence of the BAT Samoa site, going to the Security House to check on the presence of WASH in the area and the septic tank where all wastewater from the Security House is discharged. The next stop was in the Conference Room where the use of water for WASH purposes was verified and all discharges went to the nearby septic tank, a tap outside was noted for washing purposes as may be required. A fuel tank of 3,000L capacity (current contents need to be provided) was also present with a bund wall at the bottom (capacity is unknown) near the generator sets cage with two used lead acid batteries (cited that can be improved as these may pose a potential source of water pollution if mishandled). A pail of used oil was found at the back of the machining area but was immediately removed and placed in an area to prevent potential spills.

Disposal of used lead acid batteries stored within the generator area by an appropriate vendor to avoid any further possible sources of contamination.
