CERTIFICATION REPORT

Alliance for Water Stewardship (AWS)

Audit Number: AO-001004

Site: **Coca Cola FEMSA - Planta Morelia**
Address: Calz La Huerta 1900, 58080, Morelia, Michoacán, MEXICO
Contact Person: CAROLINA GOMEZ OCHOA
AWS Reference Number: AWS-000635
Site Structure: Single Site

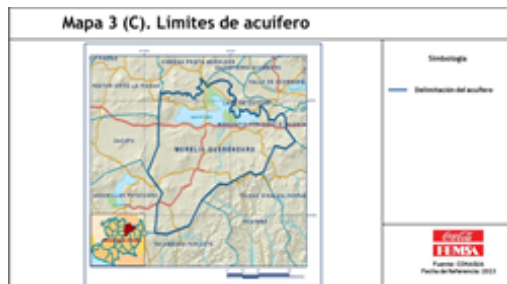
1.1.1_(C)_Mapa_de_delimitación_del_acuífero.jpg

- The watersheds that the site affects and depends on for water: the site presents a georeferenced and oriented map with a graphic scale that clearly identifies the watersheds on which it depends and which it affects.

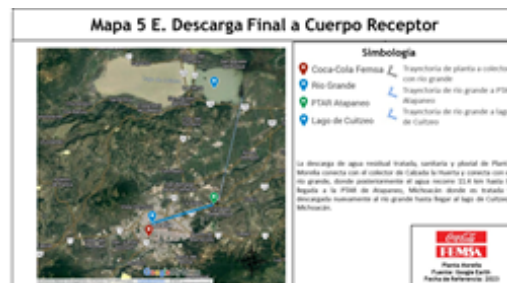
1.1.1_(E)_Mapa_de_Descarga_final_a_cuerpo_receptor.jpg

- Discharge points and wastewater service provider and final receiving water body or bodies: the wastewater and wastewater treatment service provider is "El organismo operador de Agua Potable y Saneamiento de Morelia" (OOAPAS). The discharge points are included in the plans.

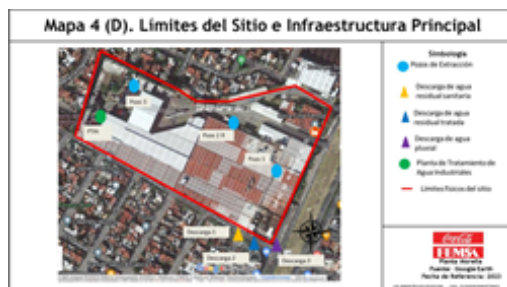
Site Boundaries.jpg

- Site boundaries: the site presents oriented site plans with scale, one of them is a georeferenced image of the Cuitzeo Lake aquifer.
- Water-related infrastructure, including piping network, owned or managed by the site: the site presents plans of its hydrosanitary, showers, rainwater, fire, drainage, and sanitary networks.
