# CERTIFICATION REPORT

## Alliance for Water Stewardship (AWS)

Audit Number: AO-001057

Site: **Coca Cola FEMSA - Planta Tocancipá**

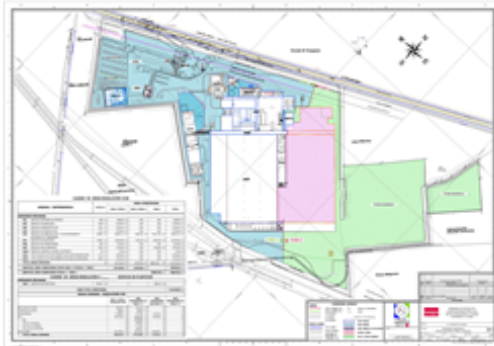
1.1.1.a Limites del Sitio.jpg

The site map is made up of 5 companies (embosa, Ser Tocancipá, Entoca, Air Liquide and Plastibol), the whole complex has a wastewater treatment plant and a pre-consumption treatment plant, which supplies the 9 production lines; they produce carbonated beverages (80.17% production) and non-carbonated beverages (19.73% production), of which 4 are PET, 2 are tetrapack, 1 hot fill and 1 B&B.

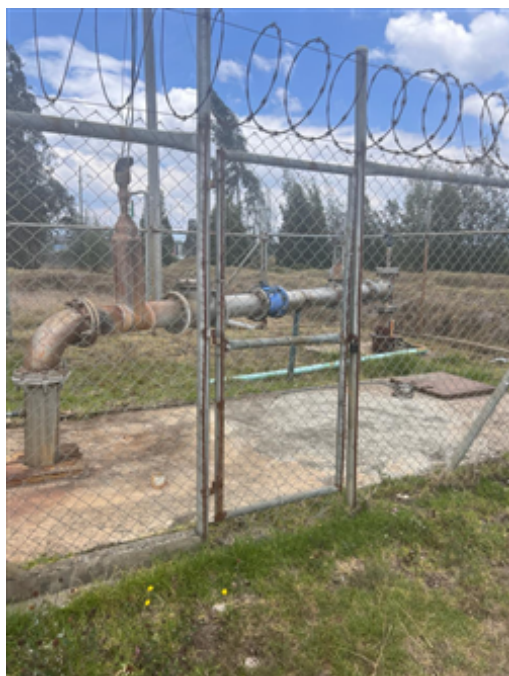
Pozo 1.jpeg

Well 1: A 930m deep well (casing) located within the boundaries of the plant site (groundwater concession with a total flow of 52.5 l.p.s (189 m3/h). The well provides the water required by the operation for industrial use only.

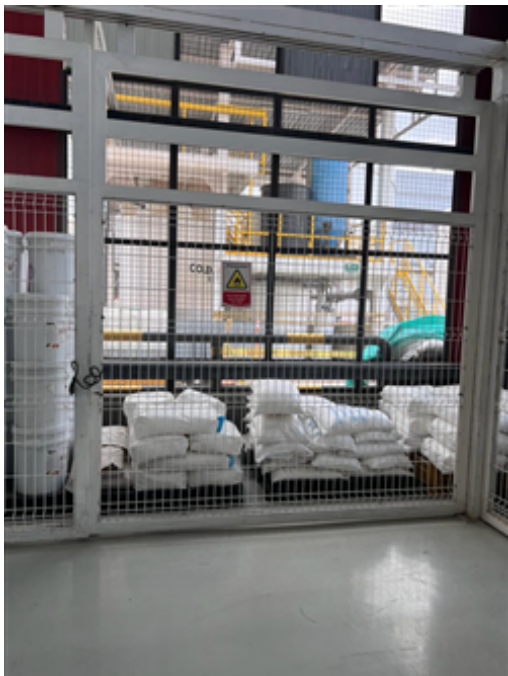
Almacenamiento quimicos PTAP.jpeg

Comment We visited the production area, hazardous waste area, waste water treatment plant, physical and chemical analysis laboratory, drinking water treatment plant, wells, toilets, showers, dressing rooms, water troughs, rainwater fencing, spill kits, PTAP laboratory, natural gas supply area, and waste collection centre.

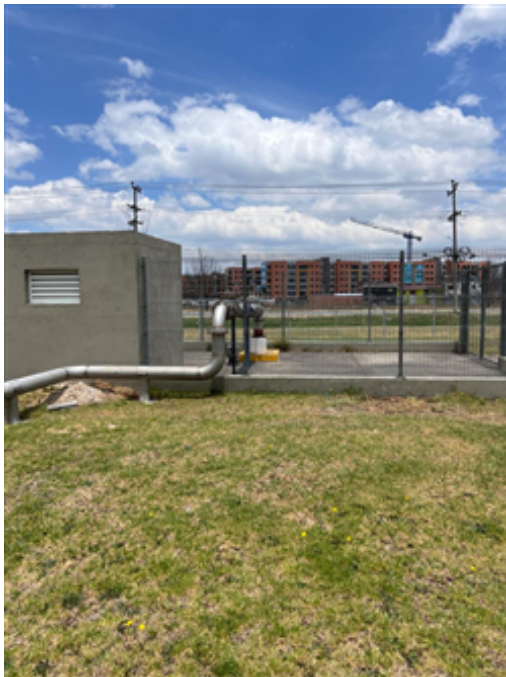
Pozo 2.jpeg

Well 2: It has a total authorised flow of 20 L.p.s, of which 0.55 can be used for domestic use and 18.45 for industrial use only for contingency, i.e. when Well 1 undergoes maintenance or there is some inconvenience that limits the use of Well 1. Well 2 has a depth of 231m and captures from 49.5 m depth.
