# CERTIFICATION REPORT

## Alliance for Water Stewardship (AWS)

Site: **Nestlé Waters UK, Buxton Factory**

Audit Type(s): Re-Certification Audit

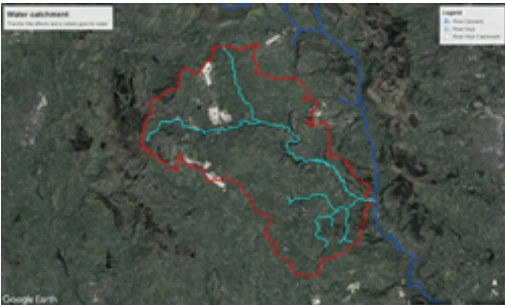
Catchment.png

Comment Catchment map provided. Note that the catchment boundary is coloured red and not white as on the key.

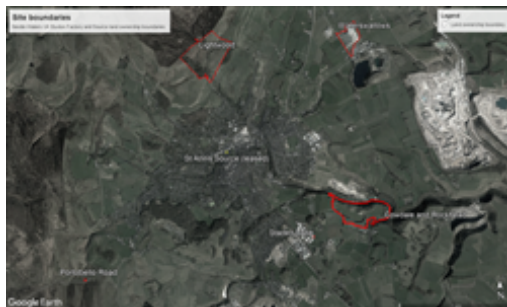
Site\_boundaries.png

The site owns land around the Lightwood and Rockhead sources, with environmental management plans in place for both areas. The Portobello compensation source is also mapped. The compensation condition is accurate as described. NWB are alerted to trigger levels in the River Wye by the EA, and compensation flow from Portobello is 1/3rd that of abstraction rate from Lightwood. Discharge is to a small stream which flows into the River Wye. The water is discharged into a stream, next to the Portobello borehole house. The site is responsible for managing the boreholes at Lightwood and Portobello.

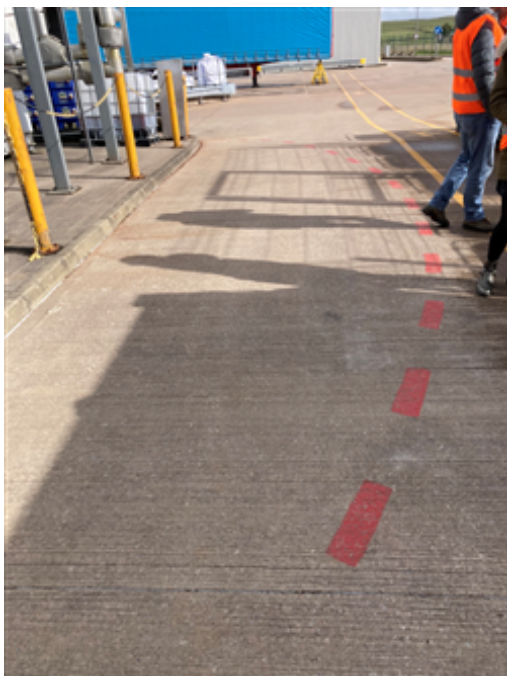
Each location was also pointed out during the site tour. A safety perimeter was seen around the Ammonia chiller plant and locked padlocks were seen on the three large hazardous chemical storage units.

Ammonia safety perimeter.JPEG

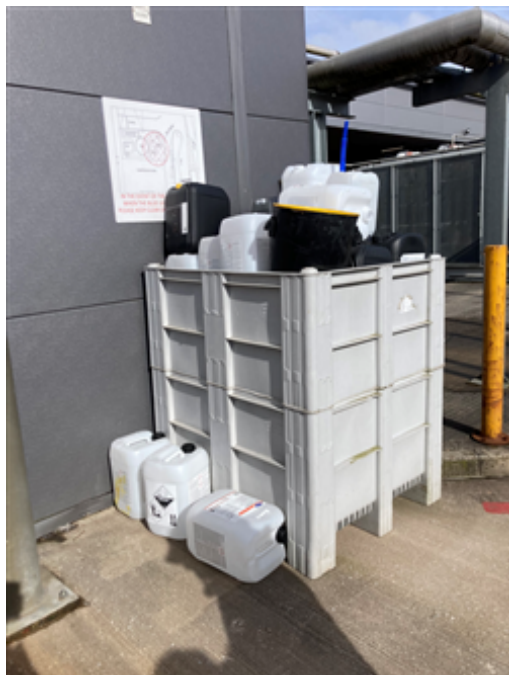
During the site tour, some containers containing COP cleaning chemicals, with the corrosive material sticker, were seen standing on the ground, instead of in a bund, next to one of the production lines. Some empty barrels with different delivery details (different company name) to NWB were seen in the CIP chemicals storage area, on a pallet. As they were empty, they were not deemed a potential issue due to the content but due to the unidentified nature. Also, some of the empty COP chemical containers (with the corrosive material sticker) were also seen standing on the ground next to a storage crate, which was also full with empty containers. One of these containers did not have a lid on. Some containers were also seen lying on the ground away from the storage crate, between two of the large locked storage containers used to store hazardous materials. According to the company, the large volume of empty containers was due to some issues with the waste contractor and delayed collections that was out of the hands of NWB.

COP containers - one without lid and two on the ground.JPEG

Corrective action:	The unidentified empty metal barrels were full of cleaning rags. One Point Lesson Issued to all employees concerning the process of Cleaning of Chemicals. See uploaded file. The One Point Lesson confirms the correct process which states that all empty COP chemicals have been rinsed 3 times to remove chemical residues before moving to the storage crates. It also confirms the correct process of always keeping cleaning chemical containers in bunds.
Evidence of implementation:	One Point Lesson Issued to all employees concerning the process of Cleaning of Chemicals. See uploaded file.  The process of emptying the storage crates has been re-established following the appointment of a new Sodexo Site Services General Manager

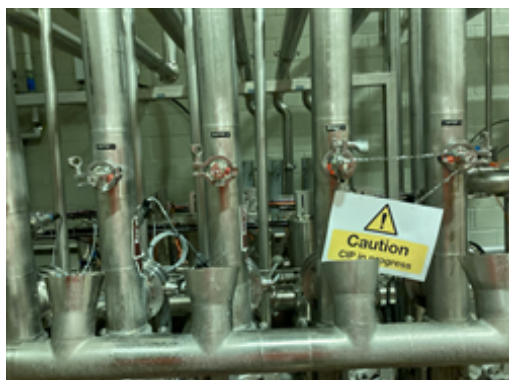
Source water pipes going into production.JPEG

Water from St Ann's spring, the two boreholes at Lightwood and the Rockhead spring (water is not currently piped from Rockhead to the factory - the connection exists though) source is piped to the factory via stainless-steel pipes. There is also a tank for municipal water outside the factory, which is connected to the sprinkler system. The company has mapped both on-site infrastructure within the factory perimeter, as well as the location and routing of the piping infrastructure from the sources Lightwood and Rockhead boreholes, as well as St Ann's well.

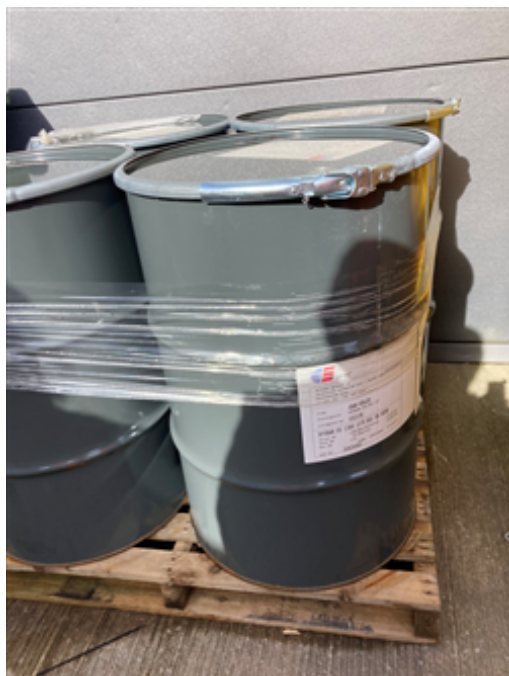
Metail containers with different company name.JPEG

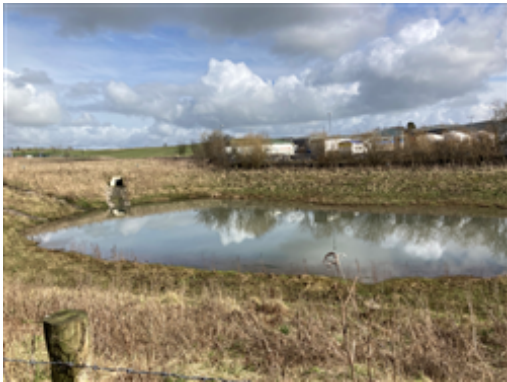
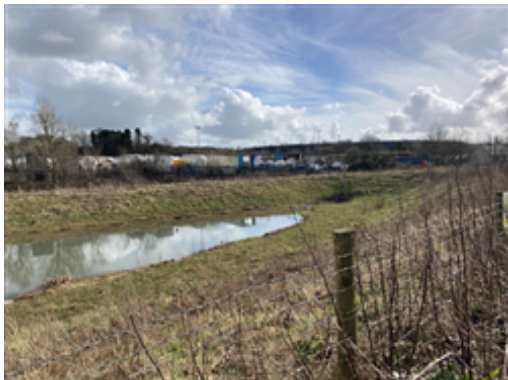
Surface water run-off and excess water from the storage tanks is discharged to the attenuation pond on site, which passes through an oil-water separator beforehand. Water discharged to the pond will infiltrate the ground, evaporate or discharge via a culvert.

Attenuation pond 1.JPGEG

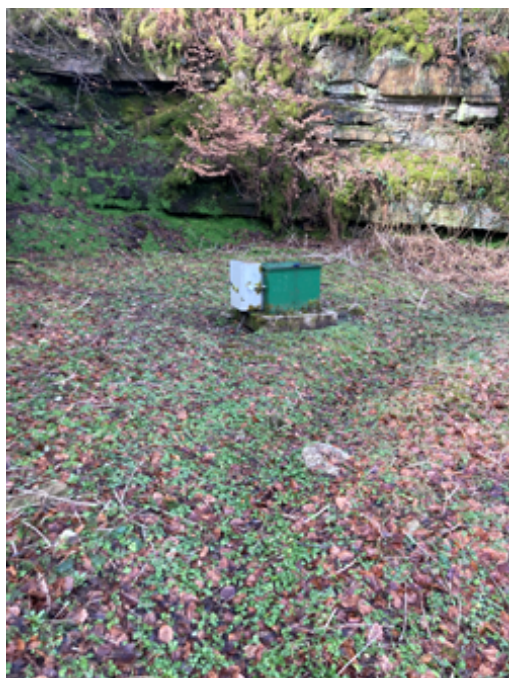
- Lightwood Source: BH 4 & BH 6 are the extraction boreholes, BH2 & 3 are for monitoring only. BH1 and BH5 are not used. There are 6 boreholes at Lightwood in total.

Lightwood borehole 6.JPGG

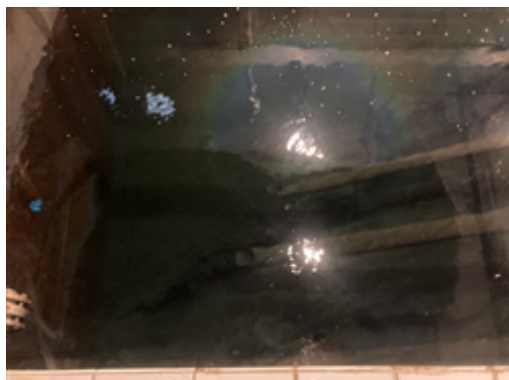
- St Ann's: there is a natural fracture in the ground where water collects in a pool, which is now the 'collection pool' for the spring.

St Anns pool rupture.JPEG

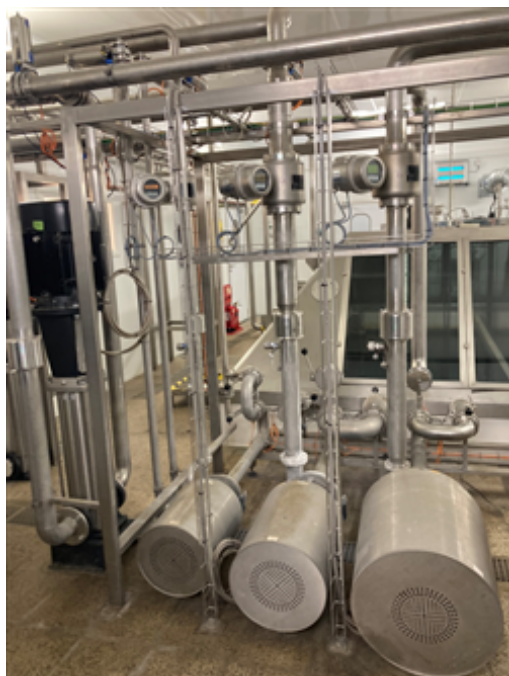
St Anns piping.JPG

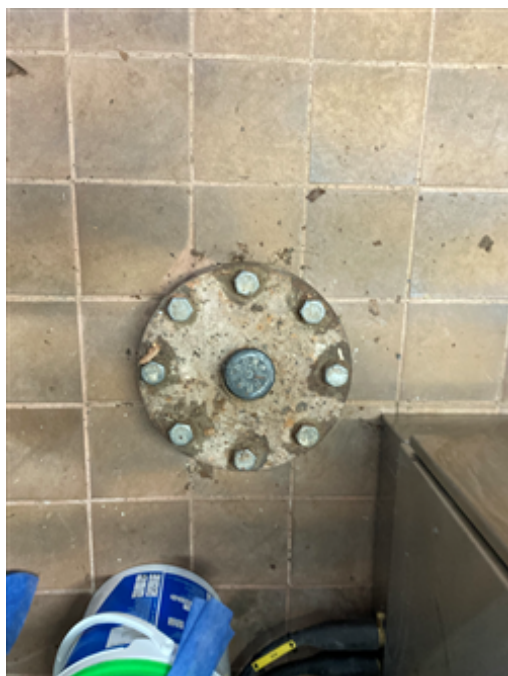
Lightwood borehole 4.JPEG

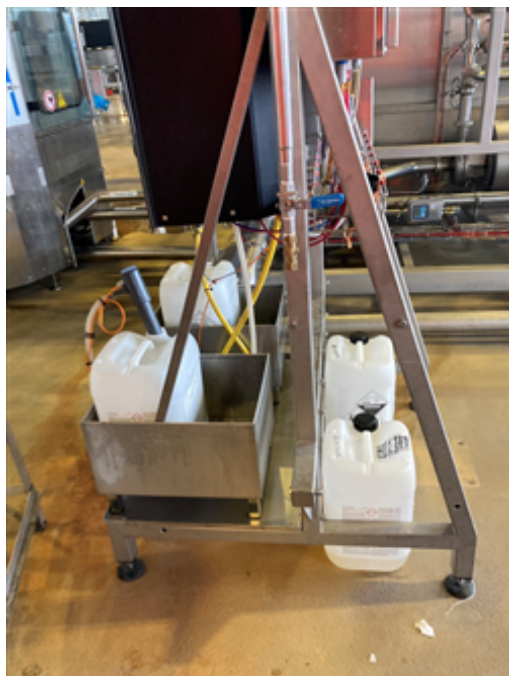
COP containers on ground next to production line.JPEG

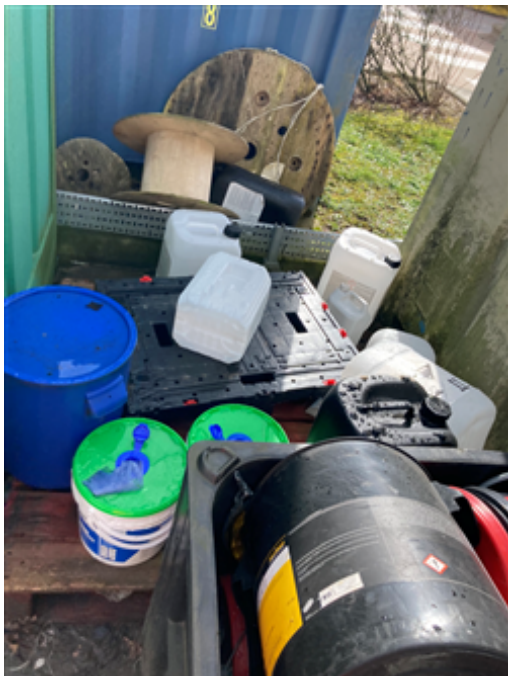
Various empty containers on the ground.JPGEG

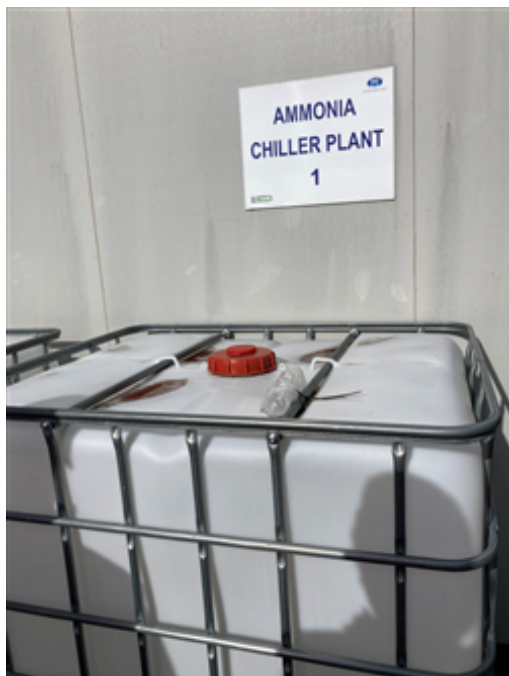
Ammonia chiller plant and container on bund.JPG
