# CERTIFICATION REPORT

## Alliance for Water Stewardship (AWS)

Site: **BAT Solomon Islands (Solomon Islands Tobacco Company)**  
Address: Ranadi Industrial Area, 00677, Honiara, SOLOMON ISLANDS  
Contact Person: Audrina Aruafu  
AWS Reference Number: AWS-000500  
Site Structure: Single Site

Audited Service(s): AWS Standard v2.0 (2019)  
Audit Type(s): Initial Audit  
Audit Start Date: 2023-Oct-18  
Lead Auditor: Elizabeth Villezar

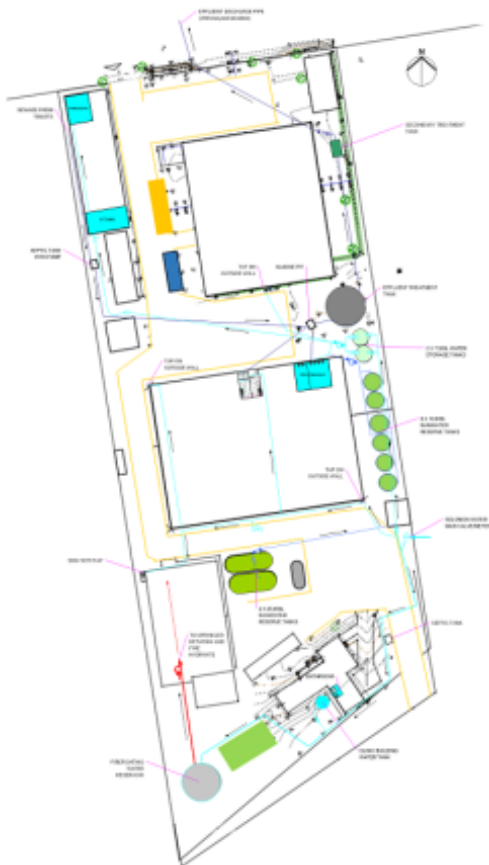
4.png

The BAT SITCO Site is being served by the Panatina Reservoir, which is situated on the ridge just above the physical site. An underground pipe network connects Panatina Reservoir to the site and is supplied via a 50mm pipe with a Valve and Water Check Meter. SIWA meter readers do a monthly meter reading for billing purposes and SITCO keeps a daily record of this water check meter reading for daily reporting purposes. Thus, Panatina water boreholes are the ultimate water source of SITCO and its ultimate discharge is the Ranadi seafront connected to an underground pipe approximately 200m accordingly from the shoreline.

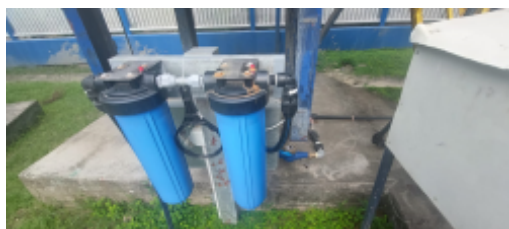
Rainwater filters.jpg

There are two sources of water within the plant, one from the Solomon Islands Water Authority and from the rainwater collected in several tanks during the rainy season (filtration system is in place).

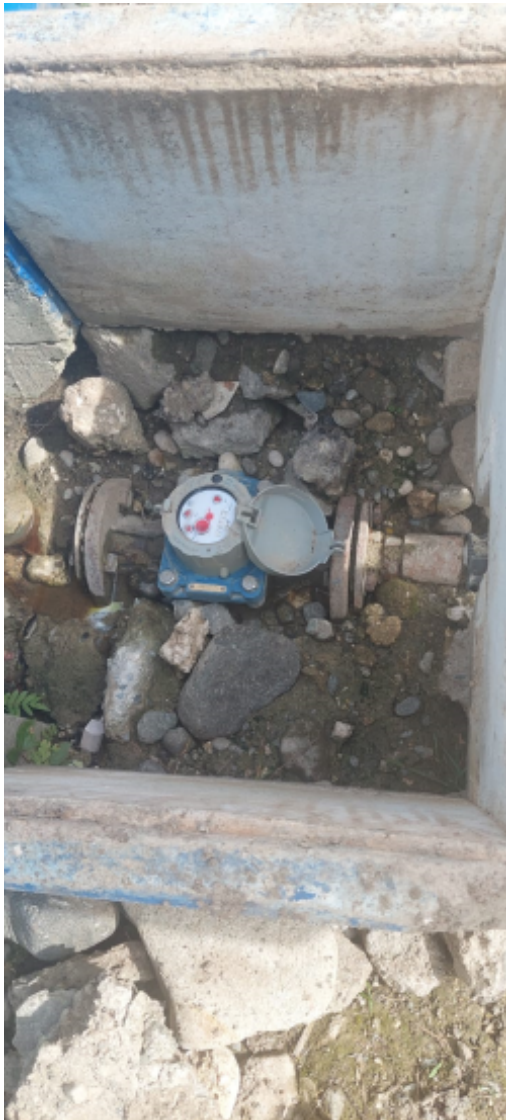
SIWA Meter1.jpg

**Comment**      The photographic pieces of evidence attached herein are those selected to be of significance to this on-site audit of BAT SITCO. These include the Solomon Islands Water Authority (SIWA) water meter where incoming water is measured, the site's water-related infrastructures - the visible piping, the water storage tanks, the waste-water treatment tank, the rainwater meter, the discharge point, and the water source - Kongulai River water intake as part of the catchment tour.
