CERTIFICATION REPORT

Alliance for Water Stewardship (AWS)

Audit Number: AO-001258

Site: **Philip Morris CR a.s.**
Address: Vitezna 1, 28403, Kutna Hora, CZECH REPUBLIC
Contact Person: Pavlina Pupikova
AWS Reference Number: AWS-000353
Site Structure: Single Site

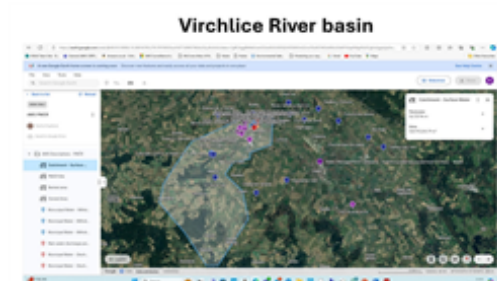
Virchlice River basin.jpg

The site has named its catchment as the Vrchlice river basin. The Vrchlice is a stream in the Czech Republic, a left tributary of the Klejnárka River. It flows through the Central Bohemian Region. It is 30.0 km long. The Vrchlice originates in the Zdeslavice exclave of the Černíny municipality in the Upper Sázava Hills at an elevation of 488 m and flows to Nové Dvory, where it enters the Klejnárka River at an elevation of 204 m. It is 30.0 km long. Its drainage basin has an area of 133.3 km². The location of the site is on the lower end of the Vrchlice. The progression of the Vrchlice is Klejnárka→ Elbe→ North Sea. The most populated settlement on the Vrchlice river is the town of Kutná Hora. The river flows through the municipal territories of Černíny, Štěporklasy, Chlístovice, Malešov, Vidice, Miskovice, Kutná Hora and Nové Dvory.

The most valuable part of the Vrchlice basin is the Vrchlice valley in Kutná Hora, which was proposed to be declared a nature reserve.

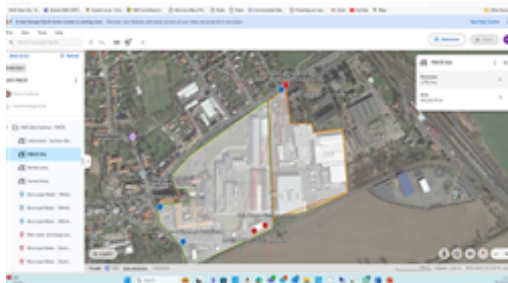
Site map.jpg

The green area on the attached map is owned by PMCR and the orange area is rented by PMCR.

There are three incoming water points on site and all are operated by Municipal company Vrchlice-Maleč a.s. There are two wastewater discharge points on site and these are operated by Municipal company Vrchlice-Maleč a.s.. The waste water goes to the WWTP (operated also by the municipal company). There are two discharge points for rain water from site, the water goes to the Vrchlice river (through the main storm sewer). The site is able to control closure in case of an environmental incident.

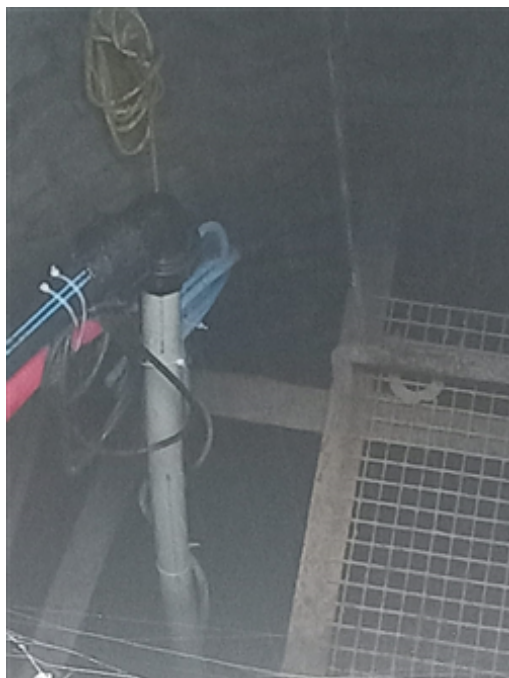
Main well.jpg

- Water-related infrastructure, including piping network, owned or managed by the site or its parent organization; found here 'Water management in Kutna Hora factory 2024-Model (1)' The facility did not show as part of infrastructure, the wells on site.

- Any water sources providing water to the site that are owned or managed by the site or its parent organization; The facility explained the main source of water for municipality as the Vrchlice river and discharge after treatment as Vrchlice river. However it is understood that the site has a number of wells however this was not shown or discussed by the site.

Corrective action:	Map properly the groundwater catchment on map and documents. - Contact involved institutes and find out all information about groundwater. Investigate more about Site wells.
Finding No:	TNR-013095
Checklist Item No:	1.3.2
Status:	In Progress - CA plan approved
Finding level:	Minor
Due date:	2025-Sep-10
Checklist item:	Site water balance, including inflows, losses, storage, and outflows shall be identified and mapped
Findings:	Although the site has provided comprehensive analysis of water used on site, it is not clear what the volume of outflow is as well as losses in the system e.g. evaporation losses.
Corrective action:	Add all inflows, outflows and losses to the Site water diagram. Do the diagram more detailed.

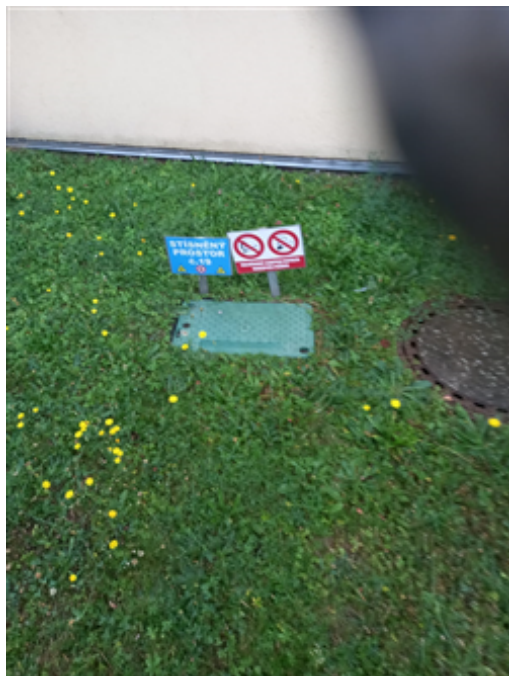
Oil separator for parking.jpg

Findings:	There was one exceedance in quarter 1 & 2 2023 of C10-C40 limit of 0.5mg/l at the oil separator. It is not clear how this was resolved.
Corrective action:	Improve the process and provide better evidence of resolving the exceedance of water quality.
