# CERTIFICATION REPORT

## Alliance for Water Stewardship (AWS)

Site: **Haleon - Lincoln, Nebraska**

Audited Service(s): AWS Standard v2.0 (2019)

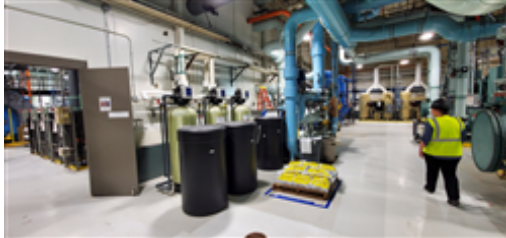
20240730\_093018 Water Softeners Central Plant.jpg

The chiller room had lots of piping with clear labeling, and the site was recovering condensate from chillers in the fire room. Softeners in the chiller room were for fire water. Next to the chiller was a boiler room with an eyewash station. Chemical stores in the boiler room had a containment pit with a closed drain - the site would soak up the pit should there be a leak. All drains on-site go directly to its primary treatment facility.

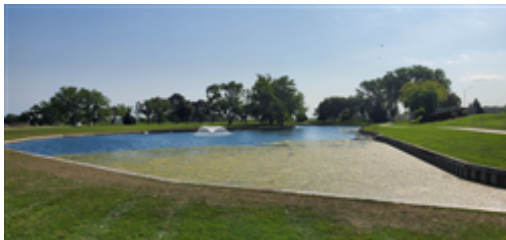
20240730\_095926 Pond.jpg

The site had many drains and underground piping to manage flooding. The sprinklers were noted to be running during the day. The stormwater retention pond included an aerator fountain, though some algae encroached because of the extreme head. The
