CERTIFICATION REPORT

Alliance for Water Stewardship (AWS)

Audit Number: AO-001300

Site: **Haleon - Guayama, Puerto Rico**
Address: State Road #3 KM 141.3, 00785, Guayama, Puerto Rico, UNITED STATES
Contact Person: Francisco Morales-Gonzalez
AWS Reference Number: AWS-000730
Site Structure: Single Site

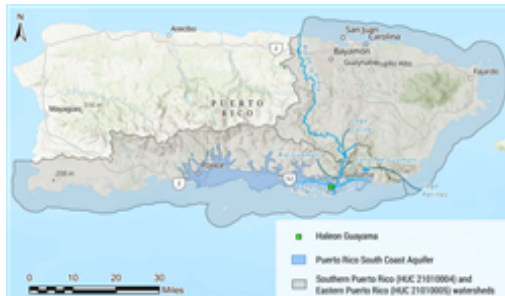
1.1.1_Catchment_Map.jpg

The site's catchment is the Southern Puerto Rico Basin. The South Coast Aquifer is the site's main source of water. Groundwater level monitoring in the aquifer shows how water storage volumes change yearly. Freshwater recharge to the aquifer takes place primarily through rainfall and secondarily through streamflow infiltration. Groundwater withdrawal to meet water demands is the primary source of aquifer depletion. Groundwater levels can, therefore, act as a proxy for the water balance in the catchment.

The site also receives a secondary water supply from PRASA, which sources its water primarily from two surface-water reservoirs (Lago Carite and Lago Patillas). Water levels in these two reservoirs can act as proxies for the water balance of PRASA supplies.

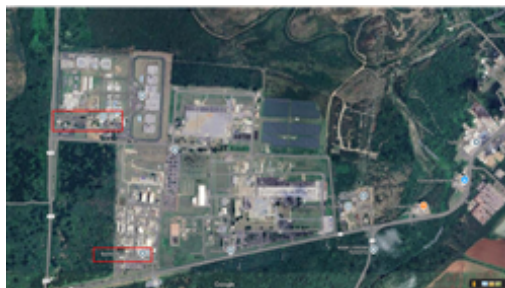
site map.png

Haleon (legally registered as PF Consumer Healthcare) owns and manages the site at State Road #3 KM 141.3, in Guayama, Puerto Rico, 00785 (17.963443, -66.148375). Glaxo Smith Kline owned the site until 2022, when Haleon spun off as an independent company. The manufacturing facility produced consumer healthcare products such as Advil, Nexium, Emergen-C, Centrum, and Caltrate. The facility spans 176 acres with 883,000 square feet of building space. The site employs 852 regular employees and 108 contingent workers. Key infrastructure includes three on-site water wells, a wastewater treatment plant with reverse osmosis system, cooling towers, fire tanks, and storage tanks. The facility generates annual intercompany sales revenue of \$453 million through its manufacturing operations.
