CERTIFICATION REPORT

Alliance for Water Stewardship (AWS)

Audit Number: AO-001384

Site: **Sanpellegrino S.p.A stabilimento San Giorgio in Bosco**
Address: Via Valsugana 5, 35010, San Giorgio in Bosco -PD, ITALY
Contact Person: Angela Midollini
AWS Reference Number: AWS-000668
Site Structure: Single Site

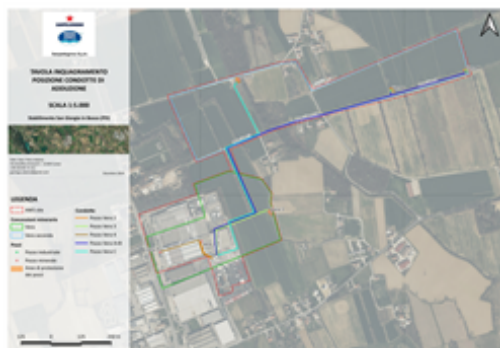
8 TAVOLA CONDOTTE DI ADDUZIONE_Rev.01_page-0001.jpg

The water is transported to the plant with underground steel pipes that are also part of the AWS site. The water from the wells is used for all the needs of the plant: bottling, industrial, and civil users. The pumped water separated from mineral and industrial is collected in external tanks and distributed through two rings that feed the production lines (bottled water under the Vera brand) and a line (industrial water) for soft drinks, the syrup room, utilities, services, and offices.

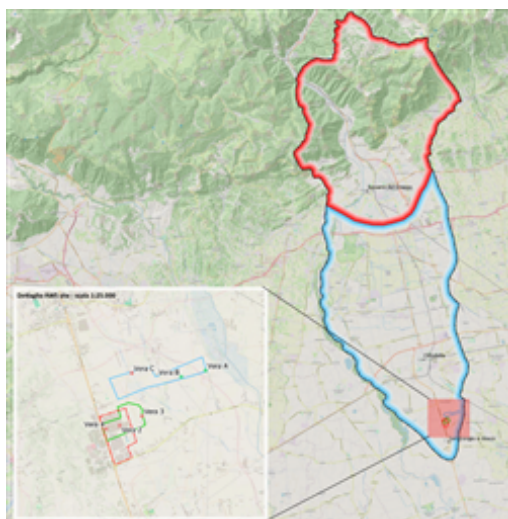
1 subcatchment.png

Within the main catchment, there is a part (sub-catchment) that has a direct correlation with the site and the areas subject to the mining concessions for the extraction of mineral water.

This area is characterized by two parts:

- **Recharge Area** (catchment of origin): which includes the primary water infiltration area or recharge area. It extends from Bassano del Grappa to the Venetian Prealps, up to an altitude of 1300 - 1400 meters a.s.l., as indicated by isotopic evaluations. The Supply area has an area of 136.96 Km². By feeding area is that area of the Veneto Pre-Alps where the infiltration of liquid and solid precipitation takes place, which is captured by the fracturing systems of the Monte Grappa area. These waters, based on what is reported by isotopic investigations, feed the deep aquifers captured in San Giorgio in Bosco. To these waters are added those coming from the apical part of the alluvial fan of the Brenta, in which the aquifer is undifferentiated.

- **Influence Area**: which contains the Sanpellegrino S.p.A. wells and mineral concessions area. This is the area through which waters move from the recharge area to the wells zone without connection with the surface. The Influence Area in the plain area is bounded to the west by the Brenta River, to the east it is delimited by the boundaries of the hydrographic basins that drain eastwards towards Castelfranco Veneto and they are not connected to the aquifers of interest. The Area of influence has an extension of 152.22 Km². The area is the sector in which there is no direct interconnection between the surface and the deep groundwater. At depth, the water is captured through the wells in the site mining concessions.

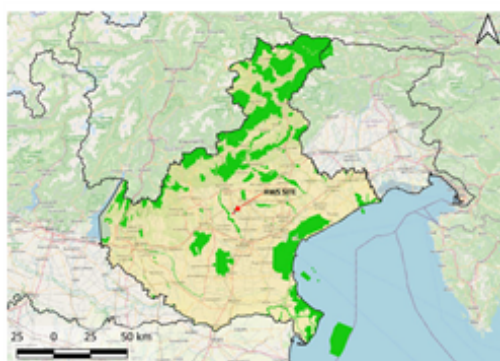
3 Natura 2000 IWRA.png

The Sanpellegrino Plant and the municipality of San Giorgio in Bosco are not included in Natura 2000 protected areas.

Figure 2 – Aree protette Natura 2000 in Veneto

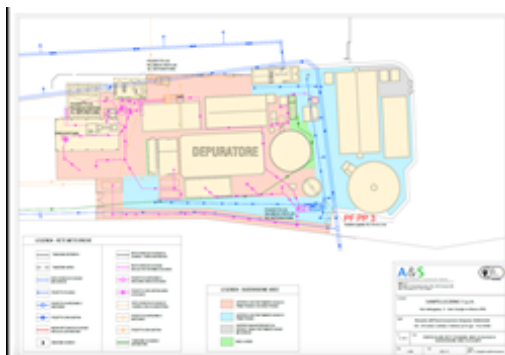
10 WWTP.png

The farm is equipped with a biological purification plant that collects and treats the

company's wastewater, in particular:

- bottle rinse water (containing traces of hydrogen peroxide or peracetic acid)
- drinks consisting of water, juices, sugars/sweeteners and flavorings
- aqueous solutions of detergents and sanitizers for cleaning systems
- domestic drains (showers, canteen, toilets)
- first rainwater of some areas such as waste pitch.

The purified water is discharged as surface water in a creek managed by Veneto Strade through an underground pipeline equipped with a sampling point..
