# CERTIFICATION REPORT

## Alliance for Water Stewardship (AWS)

Audit Number: AO-001211

Site: **BAT Bangladesh - Manikganj**  
Address: Jaigir, 1800, Manikganj, BANGLADESH  
Contact Person: Md Mahmudul Alam  
AWS Reference Number: AWS-000749  
Site Structure: Single Site

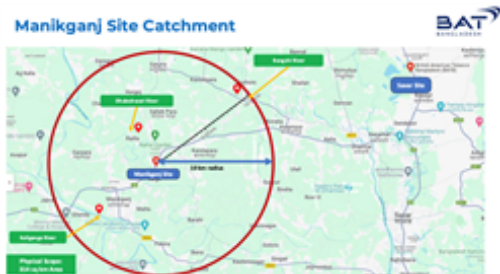
Catchment (BATB-Manikganj).png

The RDP factory is located within the Dupitila aquifer catchment as ground water catchment, and Kaliganga/Dalishery/Bongshi River catchment as surface water catchment. The source water is pumped up from on-site deep borehole, treated by on-site water treatment plant (WTP), consumed for the production process. Wastewater generated from the factory is treated through the site's Effluent Treatment Plant (ETP) before being discharged. The discharged water is absorbed into the nearby soil and eventually flows into nearby rivers (Kaliganga, Dalishery, Bongshi Rivers) during the rainy season through sub-runoff.
