CERTIFICATION REPORT

Alliance for Water Stewardship (AWS)

Audit Number: AO-001385

Site: **Nestlé Waters Turkey:Bursa**

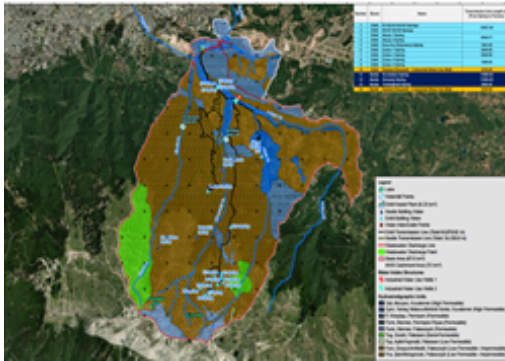
water_sources_area.png

The site has a total of 22 water sources. While 20 of them are used for bottled water production, 2 are utilized for industrial purposes (such as washing water dispensers, tap water, pipe cleaning, environmental cleaning, and cooling water). The facility has an annual water cycle of approximately 1.5–2 billion liters.

The total pipeline length transporting water from these sources to the filling facility is 66.5 km. There are two wastewater treatment plants (WWTPs) on the factory premises: one for domestic wastewater and one for industrial wastewater. The treated water is discharged in two stages into Karanlık Dere, a natural water body located in the Marmara Basin (Latitude: 44.50452; Longitude: 68.9748).

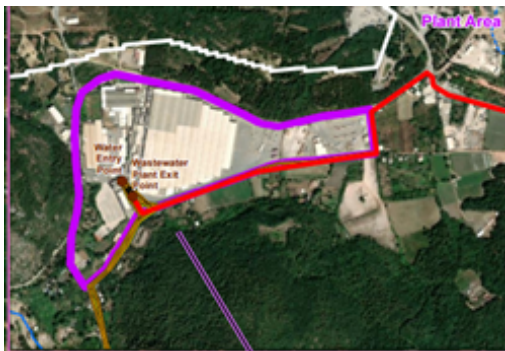
plant-area.png

The production facility covers an area of 0.23 km², and the entire site consists of natural water source points:
