CERTIFICATION REPORT

Alliance for Water Stewardship (AWS)

Audit Number: AO-001439

Site: **BAT Bangladesh Mohakhali - Dhaka**
Address: British American Tobacco Bangladesh New DOHS Road, Mohakhali, 1206, Dhaka, BANGLADESH
Contact Person: Afnan Rahman
AWS Reference Number: AWS-000442
Site Structure: Single Site

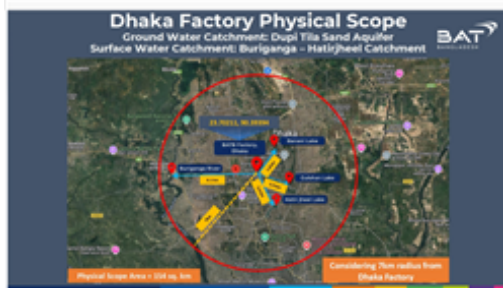
BATB-Dhaka_Catchment.jpg

The site discharge wastewater generated from the factory is treated through the site's Effluent Treatment Plant (ETP) before being recycled. Only the rainwater flows into the Hatirjheel and Buriganga Rivers; the Hatirjheel lakes ultimately flow to the Balu River.
