CERTIFICATION REPORT

Alliance for Water Stewardship (AWS)

Audit Number: AO-001440

Site: **BAT Bangladesh GLTP - Kushtia**
Address: British American Tobacco Bangladesh Chourhas, 7000, Kushtia, BANGLADESH
Contact Person: Md Mahmudul Alam
AWS Reference Number: AWS-000443
Site Structure: Single Site

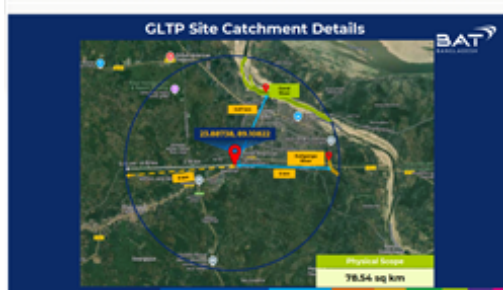
GLTP site Catchment.png

The GLTP factory is located within the Faridpur aquifer catchment as ground water catchment, and Gorai/Kaliganga River catchment as surface water catchment. The source water is pumped up from on-site deep borewells, treated by on-site water treatment plant (WTP), consumed for the production process. Wastewater generated from the factory is treated through the site's Effluent Treatment Plant (ETP) before being discharged. The discharged water flows into nearby rivers (Gorai). Gorai river is the major river catchment. Gorai-Madhumati River is a principal distributary of the Ganges.

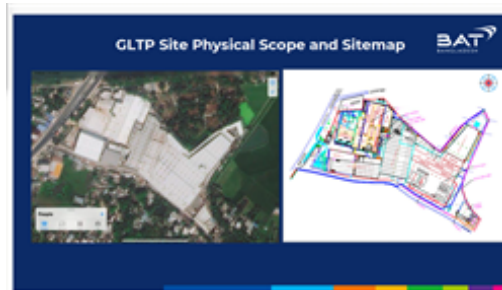
GLTP site physical scope.png

The site's water-related infrastructure includes borewells, Effluent Treatment Plant (ETP), Water Treatment Plant (WTP), water reservoir tank, rainwater collection tank, septic tanks, fire water tank, and boiler.

The wastewater generated from the process is treated at the site's Effluent Treatment Plant (ETP) before being discharged into the municipal drainage system, which flows into the nearby Gorai River. Sewage wastewater is stored in a septic tank and later collected by the Kushtia Municipality. Additionally, stormwater is also discharged into the municipal drainage system, ultimately flowing into the Gorai River.
