CERTIFICATION REPORT

Alliance for Water Stewardship (AWS)

Site: **Abbott Temecula CA facility**

Audit Type(s): Re-Certification Audit

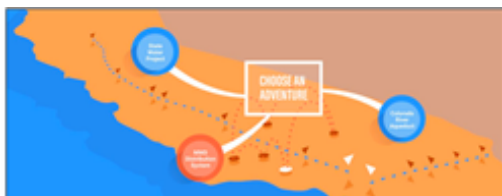
Figure 10a Ultimate Water Source
Source: <https://www.medi20.com/how-we-get-our-water/>

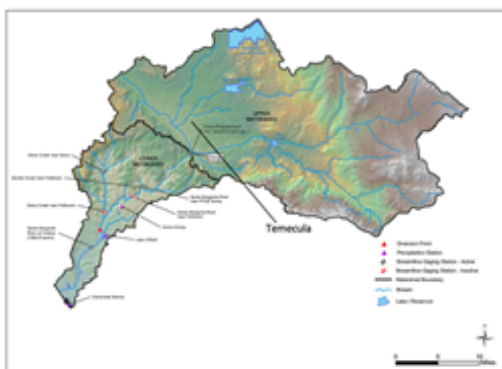
Figure 2: Santa Margarita River Watersheds - Upper and Lower Watersheds
(Source: Microsoft Word - Final Fish Passage Study v 8 (subr.docx))

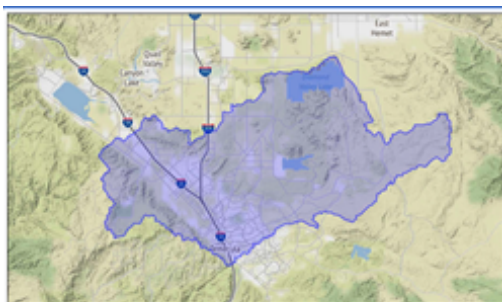
Figure 4: Murrieta Creek Sub-watershed - HUC 10

The site is located within the Murrieta Creek Sub-watershed (HUC 10 – 1807030204), a sub-basin of the Santa Margarita River Watershed (HUC 8 – 18070302). The immediate sub-unit is the Long Canyon-Murrieta Creek Sub-watershed (HUC 12 – 180703020407). The Santa Margarita Watershed spans approximately 750 square miles, with 588 square miles comprising the Upper Watershed where the site is physically located.

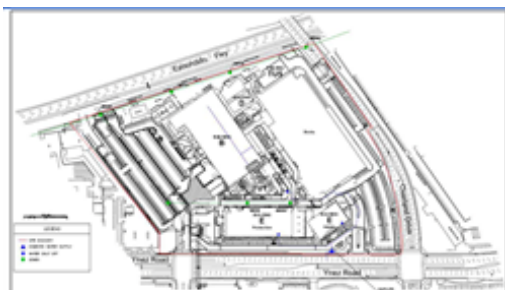
Figure 6 Site Boundaries
(larger size drawing available in separate Figures file)

The Abbott Vascular site is located at 26531 Ynez Road, Temecula, California, within Riverside County. It is positioned near key transport infrastructure, with Ynez Road to the east, Interstate 15 to the west, Overland Drive to the north, and a car dealership to the south.
