CERTIFICATION REPORT

Alliance for Water Stewardship (AWS)

Audit Number: AO-001488

Site: **Nestlé Waters Benelux S.A.**
Address: Rue du Bois, 100, 6740, Etalle, BELGIUM
Contact Person: Maxime Gillet
AWS Reference Number: AWS-000675
Site Structure: Single Site

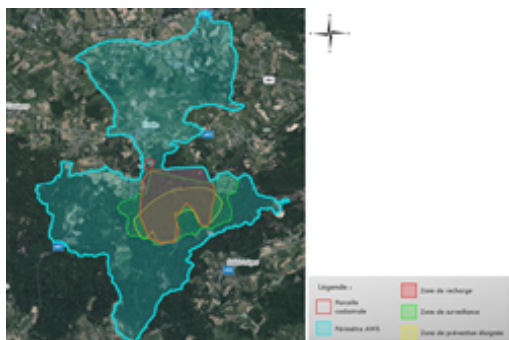
Figure 1 - AWS Physical scope (southern region Laclaireau catchment northern region part of the Semois I sub-catchment) (Source 1.1.1).jpg

Findings: The site's physical scope considers two separate catchments, for which the level of detail and collected data would differ. Catchment 1: The "ruisseau de Laclaireau" containing the water sources is fully encompassed within the AWS physical scope, the definition of this catchment is compliant, and this catchment is relevant for water balance.

However, for catchment 2, a portion of the "Semois I" (sub-catchment) with the most relevant areas is contained within the AWS physical scope but the following areas not included, with the relevance for AWS outcomes:

- the villages of Sainte-Marie, Fratin, Vance and Sivry
- a section of the catchment "Semois I" both upstream and downstream of the WWTP of Sainte-Marie (zone of influence)

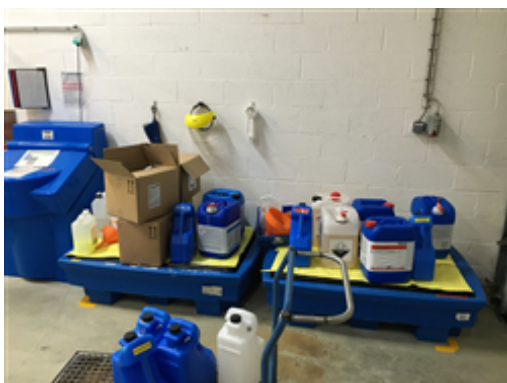
Photo 03 - Chemical product storage areas (acid and base) (source Nestlé Waters Benelux).JPG

- The 4 pipelines entering the factory (identified as GR, HdH, FDV, and HOSS) and associated flow meters (cf. Photo 1 and Photo 2);
- Chemical product storage areas (acid and base) (cf. Photo 3);
- Sampling taps for water testing;
- The pipeline discharging waters from the CIP process to the on-site neutralization station;
- A pollution control kit / spill kit (cf. Photo 4);
- 3 tanks for the CIP process (base, acid, hot water) (cf. Photo 5);
- The pipeline and associated flow meter for the “retour source”, returning unused water to the environment (loop) (cf. Photo 6).

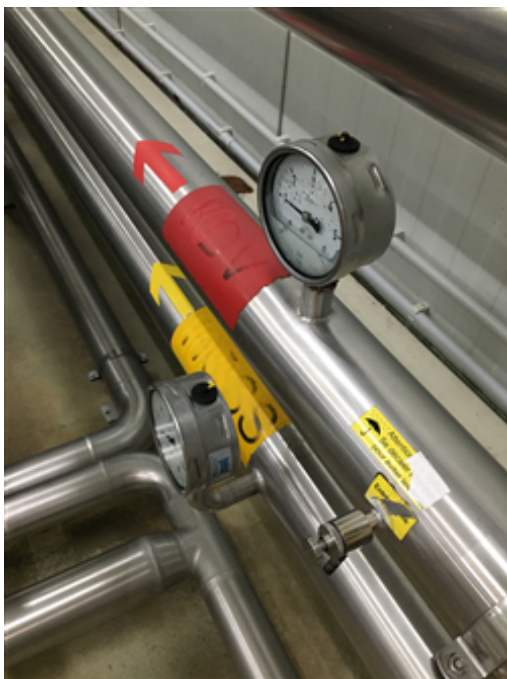
Photo 02 - Pipelines entering the factory (FDV and HOSS) (source Nestlé Waters Benelux).JPG

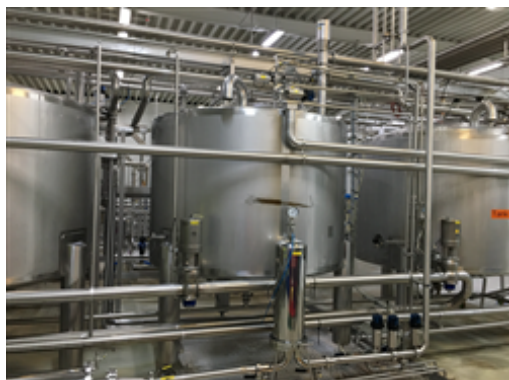
Photo 05 - 3 tanks for the CIP process (base, acid, hot water) (source Nestlé Waters Benelux).JPG

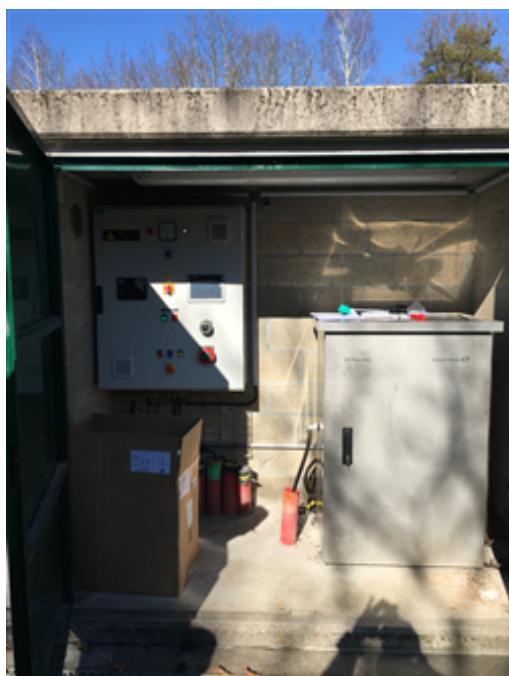
Photo 09 - Buffer pond area (pond isolation valve, sampling point, flow meter, continuous pH and temperature monitoring screen) (source Nestlé Waters Benelux).JPG

- The pond for storage and flow control at the discharge point (but no water treatment);
- Pond isolation valve;
- Downstream sampling point (sampling every m3);
- Flow meter;
- Continuous pH and temperature monitoring screen (cf. Photo 9).

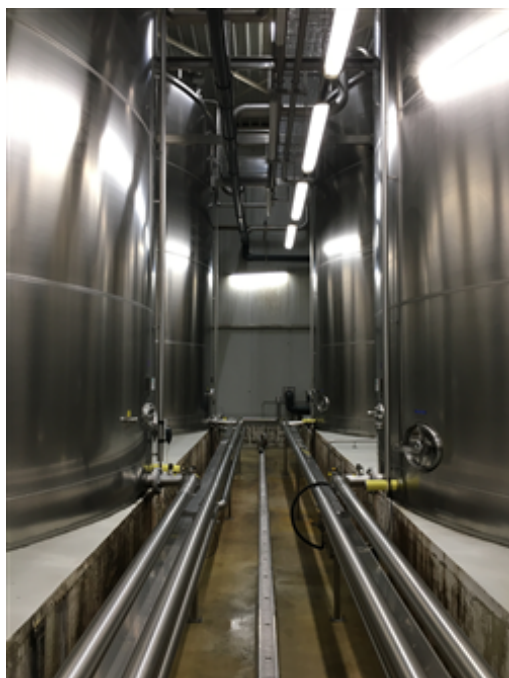
Photo 07 - 6 storage tanks of 160m3 each, to store water used in production and industrial processes (source Nestlé Waters Benelux).JPG

- 6 storage tanks of 160m³ each, to store water used in production and industrial processes (cf. Photo 7);
- The monitoring screen controlling real-time status of the tank filling.

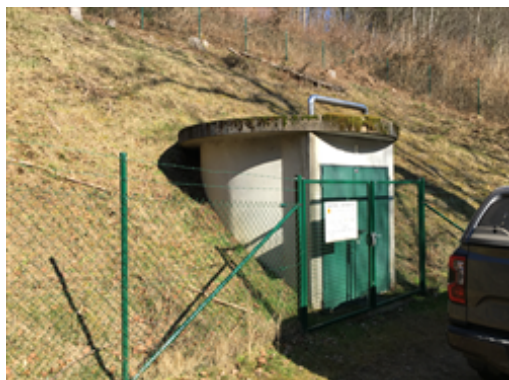
Photo 11 - Gros Ruisseau GR5 wellhouse and fenced area of the close protection zone (source Nestlé Waters Benelux).JPG

- The fenced area of the close protection zone (cf. Photo 11);
- The water well;
- The water sampling point
- The flowmeter;
- The binder for recording daily visits.

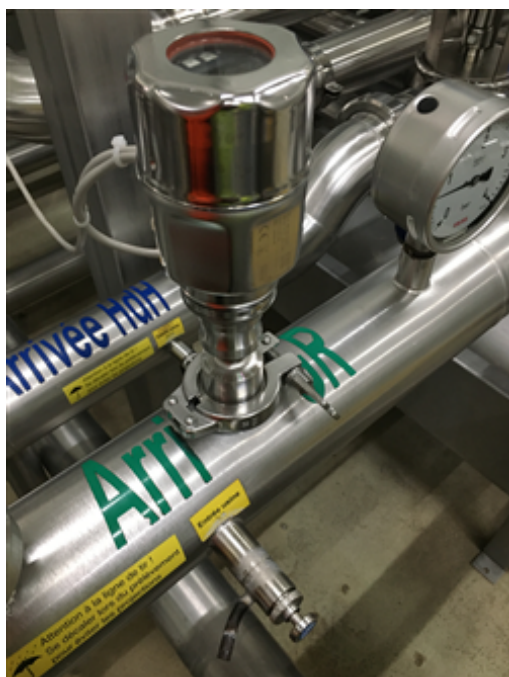
Photo 01 - Pipelines entering the factory (GR and HdH) (source Nestlé Waters Benelux).JPG

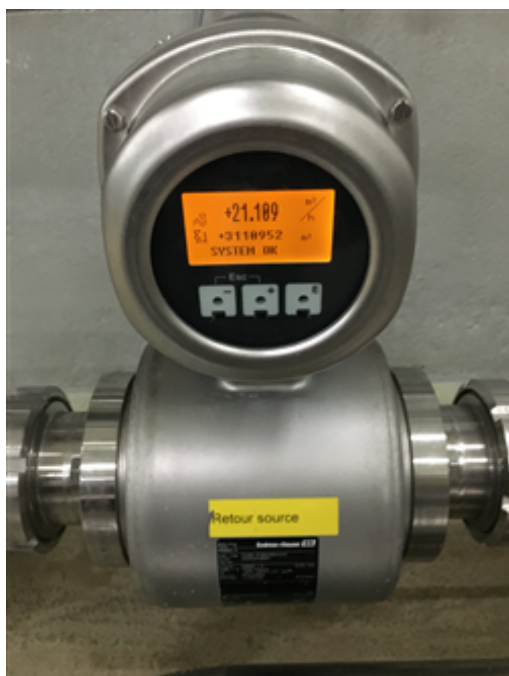
Photo 06 - Pipeline and associated flow meter for the “retour source”, returning unused water to the environment (loop) (source Nestlé Waters Benelux).JPG

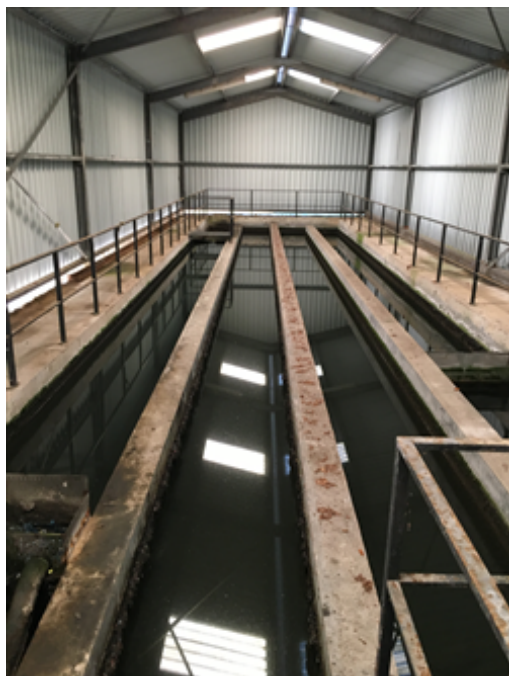
Photo 08 - Neutralization station, sedimentation basin (source Nestlé Waters Benelux).JPG

- Chemical product storage areas (acid and base);
- A pollution control kit / spill kit and the associated emergency response sheet;
- The neutralization tank (pH adjustment);
- The sedimentation basin (cf. Photo 8);
- (Outdoor) A manhole and chamber with a valve driving compliant effluents to the buffer pond and another valve that can be opened in case of a quality incident to redirect the effluents to the municipal wastewater treatment plant.
