CERTIFICATION REPORT

Alliance for Water Stewardship (AWS)

Audit Number: AO-001491

Site: **BioFunction, Shanghai BioTech Group**

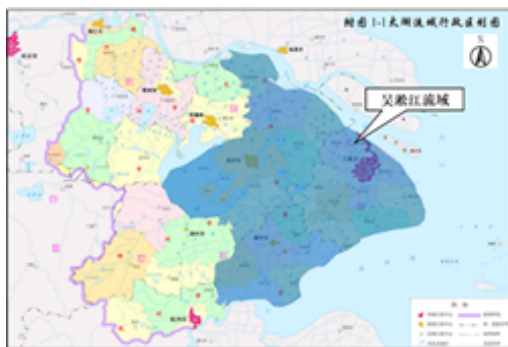
Catchment boundary.png

Based on the location of the water source and final discharge destination, the identified physical boundary for BioFunction to carry out sustainable water management is mainly the Wusong River Basin, with a focus on the relevant areas within a physical radius of 20 kilometers of Wusong River Basin.

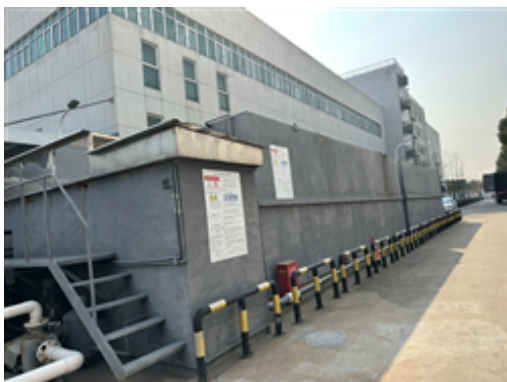
Wastewater treatment plant.JPG

The industrial wastewater in BioFunction's site area is treated by its internal wastewater station, then mixed with domestic sewage and discharged to Shanghai Jinshan Paihai Engineering Co., Ltd. for further treatment. Afterwards, it was discharged into the Donghai Sea.

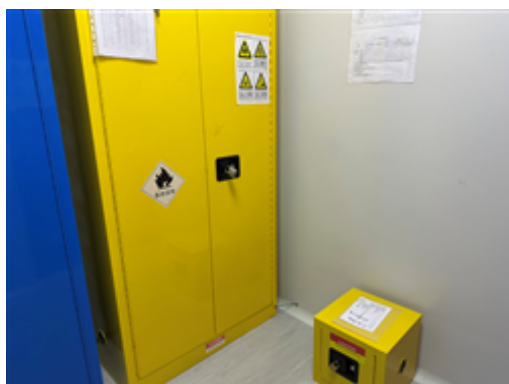
Chemical storage.JPG

The site has compiled a inventory of rainwater pollution sources, identified potential sources of rainwater pollution, including sewage treatment stations, hazardous waste warehouses, chemical warehouses, chemical storage areas, wastewater storage tanks, and exhaust gas treatment facilities, and drew a distribution map of potential pollution sources.

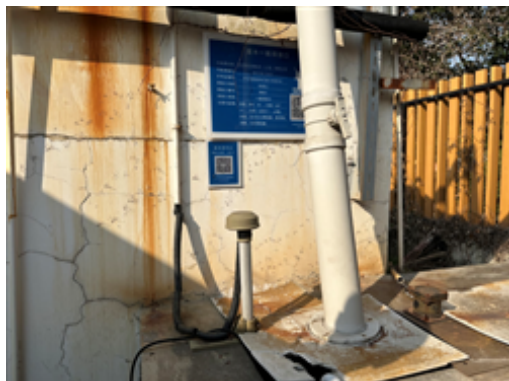
Wastewater discharge point.JPG

- The site has installed online monitoring facilities at the wastewater discharge outlet to monitor pH and COD in real-time
- Internal laboratory conducts daily testing of industrial wastewater discharge outlet and wastewater treatment processes
