CERTIFICATION REPORT

Alliance for Water Stewardship (AWS)

Audit Number: AO-001573

Site: **BAT Poland - Augustow**
Address: ul. Tytoniowa 16, 16-300, Augustów, POLAND
Contact Person: Justyna Dobko
AWS Reference Number: AWS-000457
Site Structure: Single Site

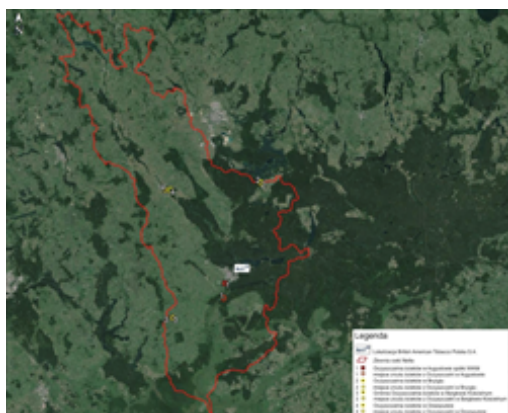
Catchment.png

The British American Tobacco Polska S.A. site in Augustów is located within the catchment area of the Netta River, which forms part of a larger hydrological sequence comprising the Netta, Biebrza, Narew, and ultimately the Vistula (Wisła) River. The site lies specifically within the catchment area spanning from the river's source to its confluence with the Biebrza River.

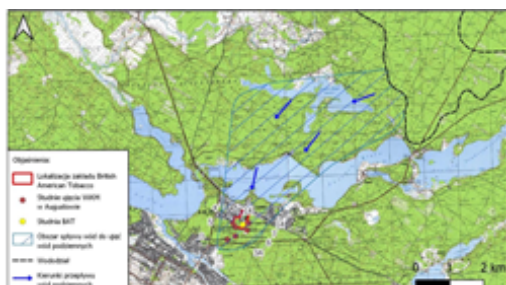
Flows of underground water.png

The site relies on groundwater from the hydrogeological unit 2 aQII/Q, within the designated groundwater body JCWPd GW200032, characterized by an unconfined aquifer composed of fine- to medium-grained sands from glacial deposits. The water table lies at a depth of approximately 6.4 to 8.0 meters below ground level. Due to the lack of an overlying impermeable layer, the aquifer is considered to have high vulnerability to potential contamination. Groundwater flows in a southwesterly direction toward the Netta River. In the broader regional context, the nearest Major Groundwater Body (GZWP 217 – Pradolina rzeki Biebrzy) lies to the southwest and is composed of multiple aquifer layers, including shallow, intermorainic, and subglacial strata. These aquifers are of generally good quality and are used for municipal water supply.

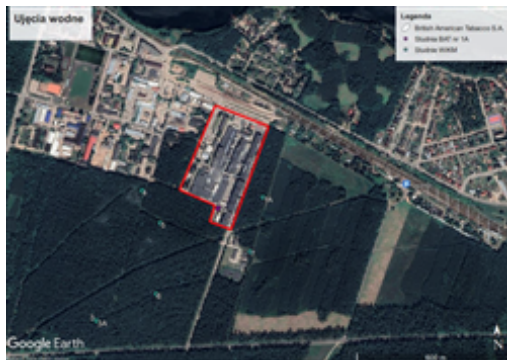
Facility_map.png

Water for the site is supplied exclusively through the municipal network managed by Wodociągi i Kanalizacje Miejskie Sp. z o.o. (as external provider) and the site's own on-site deep well (designated as well 1A). The site includes two internal water treatment stations—one in the PMD building and another in the boiler house—operating on a two-stage process involving softening and reverse osmosis (RO). Softened and demineralized water is collected in retention tanks and distributed within the site for production and boiler use.

Wastewater generated at the site falls into several categories: industrial wastewater from production activities, domestic wastewater from sanitary and staff facilities, wastewater from water treatment stations, and water used in a scrubber system for air purification. These combined wastewater streams are discharged into the municipal sanitary sewer system, which directs them to the Augustów municipal wastewater treatment plant. After treatment, effluent is released into the Netta River.

Stormwater, including runoff from roofs and paved surfaces, is routed through the municipal stormwater drainage system. The ultimate receiver of this stormwater is Lake Biale. The site itself is designed with surface-level drainage and does not contain notable terrain depressions or channels that might collect contaminants.
