# CERTIFICATION REPORT

## Alliance for Water Stewardship (AWS)

Audit Number: AO-001643

Site: **Nestle Waters Herrera del Duque**  
Address: Polígono Industrial El Borbollón, num. 7, 06670, Herrera del Duque, SPAIN  
Contact Person: Ivan Alvarez  
AWS Reference Number: AWS-000391  
Site Structure: Single Site

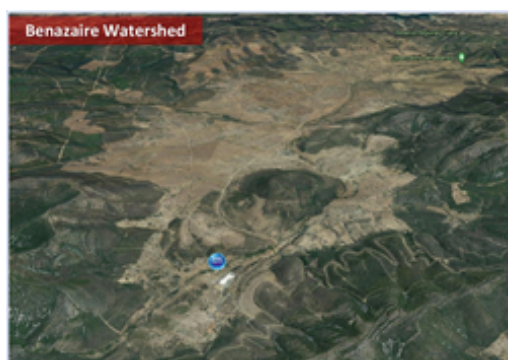
Benazaire watershed.jpg

The site is located in La Siberia Biosphere Reserve (LSBR) and depends on the Guadiana basin as the main catchment, with its smaller sub-catchment, Benazaire, located within. The site discharges into the small Benazaire stream that runs next to the facility, which then flows into the long Guadiana River flowing westwards through Spain and eventually crosses the boarder with Portugal. It discharges into the Gulf of Cádiz (Atlantic Ocean) between the Spanish town of Ayamonte and the Portuguese city of Vila Real de Santo António).

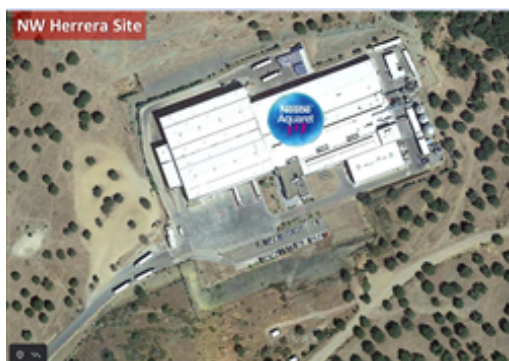
NWE aerial.jpg

The site produces two brands of bottled mineral water, "Nestlé Aquarel" and "Fuente Dehesa", in different size formats from 33cl up to 8l. All water usage on site is spring water withdrawn from Las Jaras and Encinas springs, including the water used for WASH facilities, fire system, industrial cleaning purposes and the cooling towers. Depending on the use, the site deploys different treatment technologies.
