# AUDIT REPORT

## Alliance for Water Stewardship (AWS)

Audit Number: AO-001665

Site: **Coca Cola FEMSA - Planta Sabino**

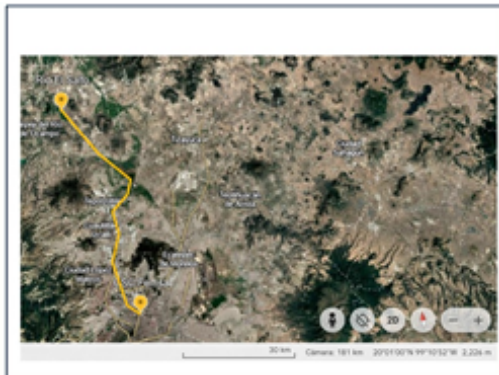
Descarga de agua residual – Río El salto.jpg

Wastewater is discharged into the public sewage system, then into the central emitter, and from there into the El Salto River in the Cuautitlán River Basin.

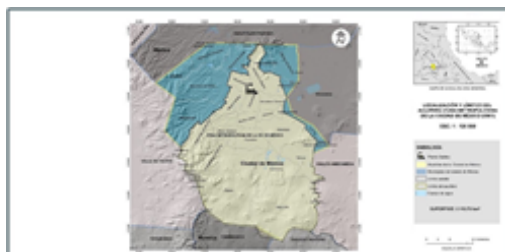
Acuifero - ZMVM.jpg

The aquifer of the Metropolitan Zone of the Valley of Mexico supplies the Site. Mexico City and its conurbation depend primarily on the aquifer for their drinking water supply. The city and the aquifer are, for the most part, separated by a clay aquitard. The aquitard is approximately 50 meters thick, while the aquifer extends to depths of more than 800 meters. Wells with depths ranging from 100 to 400 meters are located within the aquifer.

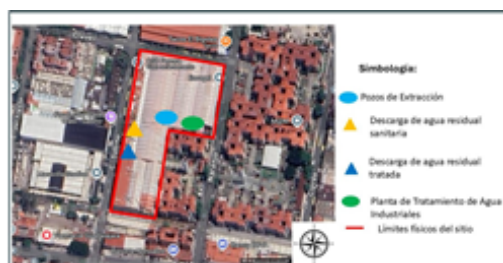
Limites del sitio.jpg

The Site, located in Mexico City, is dedicated to the production of 20L purified water jugs. The Site is located in an urban area, bordered by local businesses, houses, schools, and other industries.

The Site has a total area of 13,160 m2 and a built-up area of 18,578 m2.
