CERTIFICATION REPORT

Alliance for Water Stewardship (AWS)

Audit Number: AO-001616

Site: **Abbott Spain - Granada**
Address: CAMINO DE PURCHIL 68, 18004, Granada, SPAIN
Contact Person: Maria Luisa Montealegre
AWS Reference Number: AWS-000445
Site Structure: Single Site

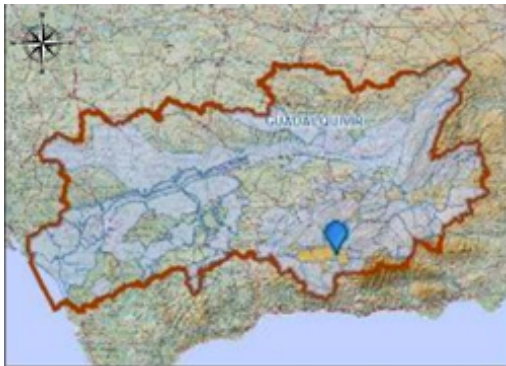
Guadalquivir basin & site location.jpg

The Abbott Laboratories site in Granada, Spain, is located within the Guadalquivir River Basin. The city of Granada itself lies within the Granada Basin (Depresión de Granada), which is an intramontane basin. The main river flowing through Granada, the River Genil, is a major tributary of the Guadalquivir River. Therefore, the site in Granada is within the sub-catchment of the Genil River, which in turn belongs to the larger Guadalquivir River Basin District (Demarcación Hidrográfica del Guadalquivir).

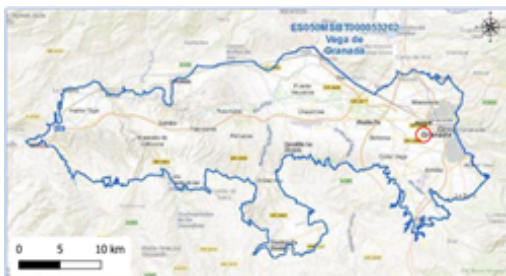
Aquifer Vega de Granada.jpg

The Granada Basin (Depresión de Granada), where the site is located, is a complex geological and hydrological area. The relevant groundwater aquifers are primarily associated with the Quaternary alluvial deposits and the underlying Neogene sediments.

1. Upper Layer / Phreatic Aquifer (Unconfined Aquifer): corresponding to the shallowest groundwater, found within the most recent alluvial deposits (sands, gravels, silts) of the Genil River and its tributaries, particularly in the river plain areas.

2. Deeper Aquifers (Confined or Semi-Confined): Beneath the Quaternary alluvial deposits and within the broader Neogene sediments (Miocene-Pliocene formations), there are deeper, often more extensive, aquifers. These layers are composed of various materials, including conglomerates, sandstones, marls, and clays. The degree of confinement depends on the interbedded layers of less permeable materials (like clays or marls).

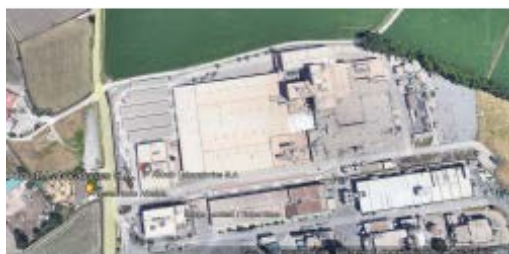
Site.jpg

Short description of the site: The site consists of three main buildings: production, R&D building, and the office tract. Auxiliary buildings include the pre-treatment of the incoming water, the hazardous and non-hazardous waste stores, the boiler house, fire water house, cooling towers, docking bays and primary product delivery zones as well as personnel car parking areas. There are currently 306 employees, and 21 interns, as well as the following on-site contractors: Security (5) and catering (3).
