# CERTIFICATION REPORT

## Alliance for Water Stewardship (AWS)

Audit Number: AO-001755

Site: **British American Tobacco Investment - Romania**

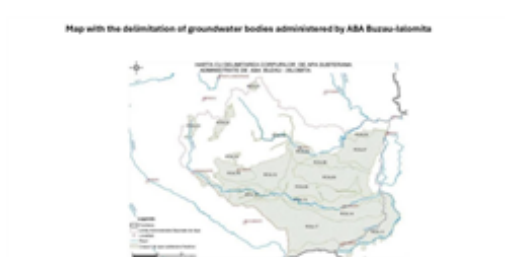
Groundwater bodies administered by ABA Buzau-Ialomita.JPG

The groundwater body beneath the site is of the phreatic type, characterized by porous and permeable alluvial deposits of Quaternary age. The aquifer consists of alternating layers of sand, gravel, and cobbles arranged in a cross-bedded structure, facilitating efficient groundwater flow and recharge.

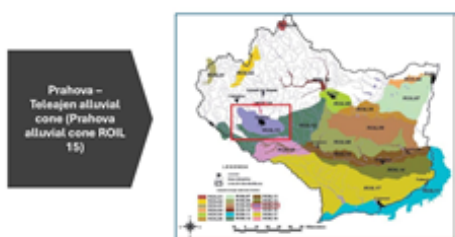
Prahova – Teleajen alluvial cone.JPG

The BAT Ploiești site obtains its primary water supply from underground sources within the Prahova–Teleajen alluvial cone area (ROIL15). This is the main source of water for the facility.
