CERTIFICATION REPORT

Alliance for Water Stewardship (AWS)

Site: **Coca Cola FEMSA - Planta Cuautitlán**

Audit Type(s): Initial Audit

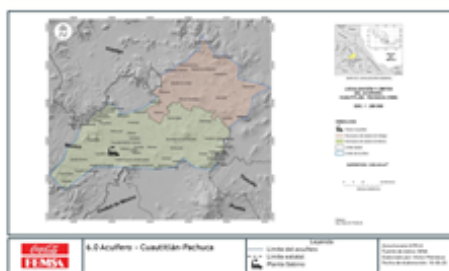
6.0_Acuifero_CuautitlanPachuca.jpg

The Site is supplied by the Cuautitlan-Pachuca aquifer. Based on the materials composing the valley, the Cuautitlan-Pachuca aquifer is primarily an unconfined to semi-confined aquifer system. It is hosted mainly within volcanic igneous rocks (basalts, tuffs, and andesites) and some lacustrine sediments. The main water-bearing layers are fractured volcanic rocks, where water flows through secondary permeability. There isn't a single "impermeable layer" that defines a simple deep aquifer, but rather varying degrees of confinement due to interbedded less permeable layers (e.g., clays, consolidated tuffs). Water is extracted from various depths, often from multiple permeable layers within the volcanic sequence. The average annual availability is -229.942637 hm³/year, confirming that no more concessions can be granted. The Cuautitlan-Pachuca Aquifer is a crucial water source for a significant portion of the Metropolitan Zone of the Valley of Mexico, including municipalities in the State of Mexico (such as Cuautitlan Izcalli, Tultitlán, Ecatepec, Coacalco, and Tecámac) and the State of Hidalgo (Pachuca and its surrounding areas). It primarily supplies drinking water for urban and industrial use.

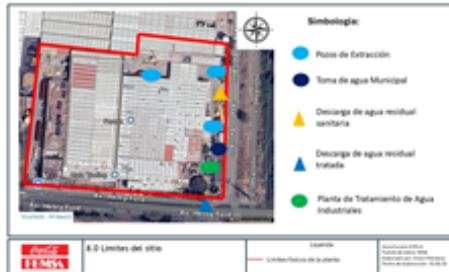
8.0_Limites_sitio.jpg

The Site is located in the Cuamatla industrial zone of the Cuautitlan Izcalli municipality, State of Mexico. Cuautitlan Izcalli is a significant industrial hub, known for its numerous factories, logistics centers, and warehouses. Although there are residential areas nearby, the immediate surroundings of the property are characterized by industrial parks and commercial developments. The Site covers a total area of 37,707 m², with a built-up area of 54,546.81 m².

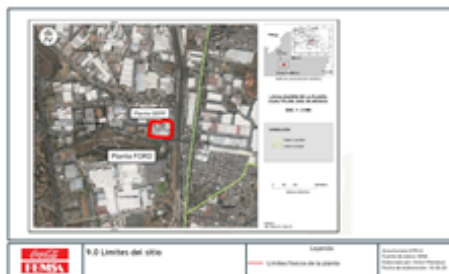
9.0_Limites_sitio.jpg

The Site operates four carbonated beverage production lines—two for non-returnable PET containers and two for returnable PET containers. The facility draws water from three deep wells, which supply two water treatment systems that purify the water to meet regulatory and corporate quality standards. The Site also has two natural gas-fired boilers that generate steam used in clarification, washing, and sanitation processes. Industrial water discharges are piped to the Industrial Water Treatment Plant. Sanitary water is transported via the sewer system to the sanitary water treatment plant (WWTP) before being discharged into the municipality's public sewer system.

1. Three groundwater wells.
2. A process water pretreatment system that colors, softens, filters out sodium, disinfects with UV light, and further filters through deep-bed and carbon filters; the water is then treated with a decalinizer system.
3. A raw water storage tank that is chlorinated after leaving the well.
4. No water use occurs in the energy facilities.
5. An industrial water treatment plant and a sanitary water treatment plant.
6. Two cooling towers.
7. The Site does not have rainwater harvesting systems.
8. The Site does have dedicated infrastructure for rainwater drainage.
9. Dedicated water supplies are available for firefighting and other emergencies.
10. The Site is equipped with sufficient infrastructure and WASH services for all personnel.
