CERTIFICATION REPORT

Alliance for Water Stewardship (AWS)

Audit Number: AO-001694

Site: **Eco Aguas y Bebidas Saludables – Planta Moreno**

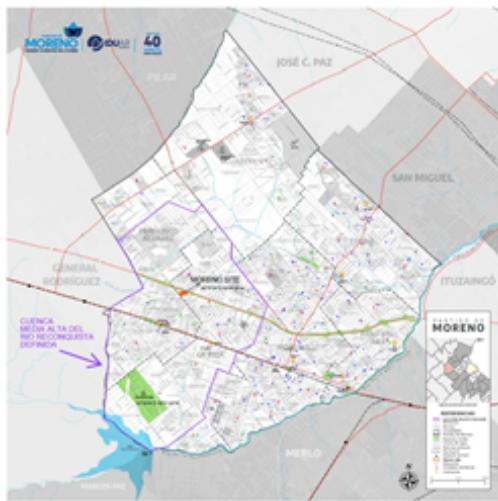
The_Reconquista_River_in_the_Middle_Catchment (2).jpg

The plant is located within the Arroyo Las Catonas sub-basin, which in turn is a tributary of the Reconquista River in the Middle Catchment. It is into this stream that the treated wastewater from the site's effluent treatment plant is discharged.

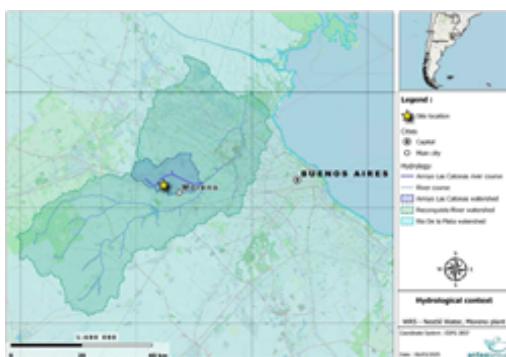
Arroyo Las Cantonas Sub-catchment.png

Treated wastewater discharge basin: Arroyo Las Catonas sub-basin, which then discharges into the Reconquista River.

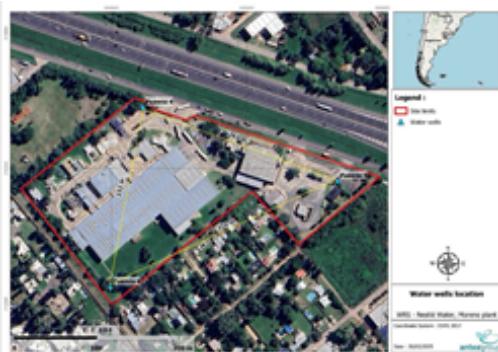
Site boundaries_ECO Aguas y Bebidas Saludables_PlantaMoreno.jpg

Site boundaries:

Physical scope includes the boundaries of the Site
