CERTIFICATION REPORT

Alliance for Water Stewardship (AWS)

Audit Number: AO-001693

Scope of Assessment: The scope of services covers the Initial certification audit for assessing conformity of CPS Argentina - Planta De Concentrados against the AWS International Water Stewardship Standard Version 2.

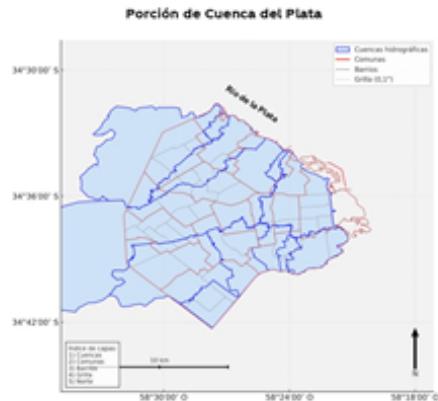
Mapa Cuenca del Plata.jpg

On a large scale, the site is part of the La Plata Basin, one of the largest in the world, with an area of over 3,100,000 km². However, the influence of the site on this catchment is negligible (representing only 0.0065% of the area), so it has been decided to limit the scope of application of the standard to a portion of the La Plata Catchment, bounded by the City of Buenos Aires.

The plant located at Luis Viale 2045, Autonomous City of Buenos Aires, is technically within the Maldonado stream catchment area. However, this catchment area has been completely piped since the 1930s and has no open water bodies or visible or direct interactions with the site. The stream was channelled underground as part of a flood control and urbanisation project, preventing any physical connection between the site and its local catchment area. According to the guidelines of the Alliance for Water Stewardship (AWS) standard, when there is no direct interaction between the site and a surface catchment area, the analysis should focus on the receiving catchment area of the water resources used or discharged. In this case, the site receives water supplied by AySA, whose catchment source is the Río de la Plata, and the effluents generated are also channelled through the sewerage system to the same receiving body. Treated wastewater discharge basin Río de la Plata catchment

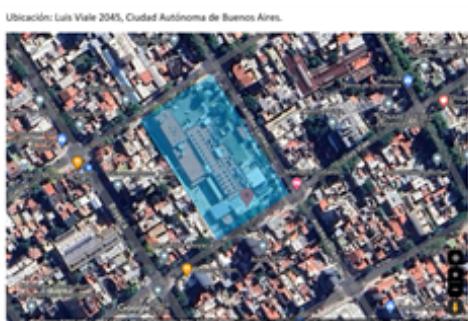
Mapa Ubicación Física del Sitio CC CPS Argentina.png

Site Location Argentine Republic, Buenos Aires, City of Buenos Aires
The Site is located in Argentina's most developed city, the City of Buenos Aires.
The Site produces solid and liquid beverage bases and beverage concentrates.
Water is a fundamental part of the process, as it is used for sanitation and also appears in finished products.

- Water is received from AYSA through three water inlets.
- The water received from AYSA is potable water; however, treated water is used for production. Therefore, the site has a water treatment plant.
The site also has a WWTP for industrial effluents from the process.

- Water is used during the production process, which is previously treated at the water treatment plant.
- There is a WWTP with primary, secondary and tertiary treatment.

- The site does not have cooling towers.
- The site has a storm drain network to contain rainwater.
- The site has a fire water tank for emergencies.
Wastewater is discharged into the AYSA sewerage network.
