CERTIFICATION REPORT

Alliance for Water Stewardship (AWS)

Audit Number: AO-001683

Site: **Cola Cola FEMSA - Planta Querétaro**

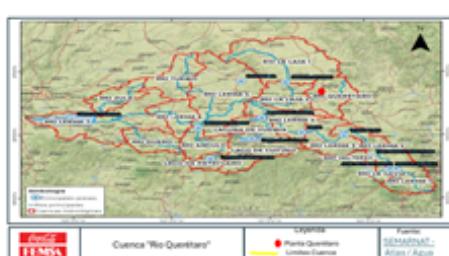
Cuenca_Rio_Querétaro.png

The Querétaro River sub-basin is of strategic importance due to its urban role and its connection to the wider Lerma–Chapala basin. The dual view (local sub-basin and regional basin) is critical to understanding water risks, shared challenges, and governance mechanisms.

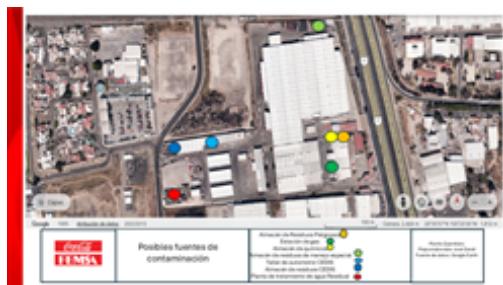
Posibles_fuentes_de_contaminación.png

1.3.5	<p><i>Potential sources of pollution shall be identified and if applicable, mapped, including chemicals used or stored on site.</i></p>	Yes
Comment	<p>The site presents a map showing possible sources of contamination within the site as evidence. It includes a list of the chemicals used or stored on site.</p> <p>During the audit, the storage sites for hazardous products and the hazardous waste storage facility were verified, and it was confirmed that preventive measures were taken to reduce risks and that equipment was available to handle different types of incidents, such as spills, accidents, or equipment failures.</p>	
	<p>Evidence:</p> <p>Indicador 1.3.5 Posibles fuentes de contaminacion</p> <p>Lista de quimicos</p> <p>QUIMICOS EN ALMACEN CEDI</p>
