CERTIFICATION REPORT

Alliance for Water Stewardship (AWS)

Site: **Spadel - Devin, Bulgaria**

Audit Type(s): Re-Certification Audit

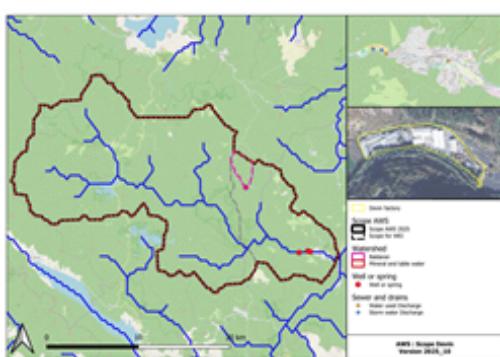
Devinska Catchment.jpg

Catchment name: the site is located in the surface water catchment of the Devinska river catchment, which is an affluent of the Vacha river.

Catchment Features: The annual average precipitation is 765 mm/year, with huge variation between years (650-800 mm). While the region is not considered as water stressed by the amount of water received, it has been subject to seasonal droughts which resulted in restrictions in water usage locally. The area is not particularly subject to flooding and water usage is mainly used for bottling water and Spas operation in addition to providing water to the local Devin municipality.

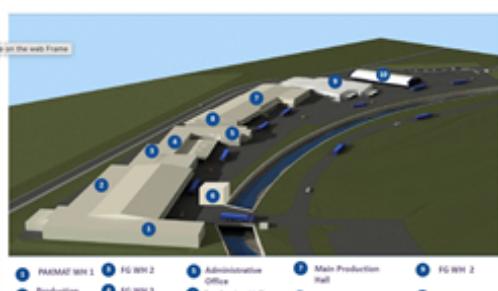
Site Map 3D.jpg

Description of site infrastructure:

1. Any water sources on site (wells, connection to municipal water supply, etc) C3 mineral water and TK1 industrial water wells are located within site boundaries. C5 (mineral water) is located about 1 km from site and Baldaran (source water) is located in the mountains about 1h driving from the site.

6. Cooling towers: closed loop cooling towers are used.
7. Rainwater harvesting infrastructure: rainwater collected is simply discharged to the nearby Devinska river through two discharge points.
