# CERTIFICATION REPORT

## Alliance for Water Stewardship (AWS)

Site: **JTI Torbali**

Audit Type(s): Initial Audit

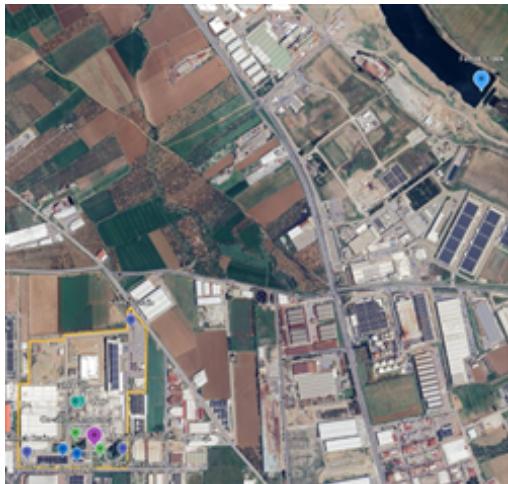
site.png

JTI Torbalı is located in Torbalı, İzmir Province, in western Türkiye. The site is primarily located in an industrial setting, with surrounding areas that include agricultural land and some residential settlements. The site produces tobacco-related products. Water is used in various production processes, including product manufacturing, steam generation for boilers, and operation of cooling towers for temperature control. Additionally, water supports utility systems such as humidification and heating/cooling systems within the facility. The site is equipped with a trigeneration system for energy production.
