# CERTIFICATION REPORT

## Alliance for Water Stewardship (AWS)

Audit Number: AO-001687

Site: **Planta Campo Grande**

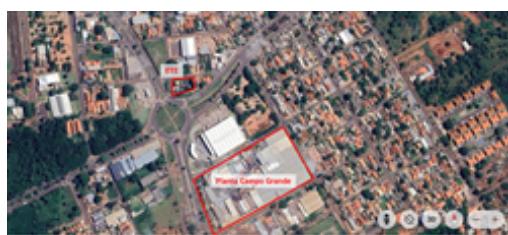
site\_boundaries.png

FEMSA Campo Grande is a soft drink bottler and is located at Campo Grande, capital of the state of Mato Grosso do Sul, Brazil. The site has around 185 employees, a total area of 36,000 m<sup>2</sup>, of which 24,000 m<sup>2</sup> is built-up area. The site is located in an industrial setting. The water is used to produce soft drinks, used in restaurant and bathrooms.

1. water wells on the site (Use to produce soft drinks) and connection to municipal water supply (Use in Effluent treatment plant)
2. Water treatment facilities
3. The water used to produce soft drinks is from wells on the site
4. Wastewater treatment facilities: The treated effluent is directed to the municipal network at the municipal wastewater treatment plant.
