CERTIFICATION REPORT

Alliance for Water Stewardship (AWS)

Site: **Nestle Waters Thailand: Surat Thani**

Audit Type(s): Re-Certification Audit

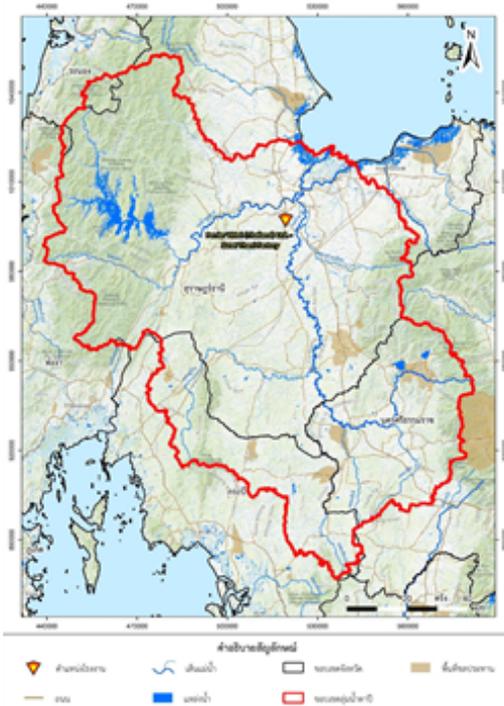
Figure 1 Map of the Tapi – Phum Duang River Basin Group (Surat Thani) catchment area.jpg

The factory located in the Tapi – Phum Duang River Basin Group (Surat Thani) catchment area, named by Office of the National Water Resources (ONWR), the previous name is Tapi river basin (in the old Thailand national river basin system). (https://www.onwr.go.th/?page_id=9893) It is one of the 3 sub basin groups of the Upper Southern region east coast rivers basin.

The Tapi River Basin covers an area of approximately 13,562 square kilometers, representing 2.62 percent of the total area of the country. It covers almost all of Surat Thani province. And it covers some areas in Nakhon Si Thammarat Province, Krabi Province, Phang Nga Province, and Ranong Province. The upstream areas are in the mountain ranges to the west and south. The main river branches into two the Tapi River and Phum Duang River join in Phunphin District, Surat Thani Province, before flowing into the Gulf of Thailand. (Figure 1 , 2)
